TREATMENT REPORT

NORMAN COURT AND NORMAN ARCH
Limestone, Sandstone, Cementitious mortar

LOCATION: Bishop's Garden
PROJECT NO. 19192
ADDRESS: Bishop's Garden
Pilgrim Road
Washington, DC 20016

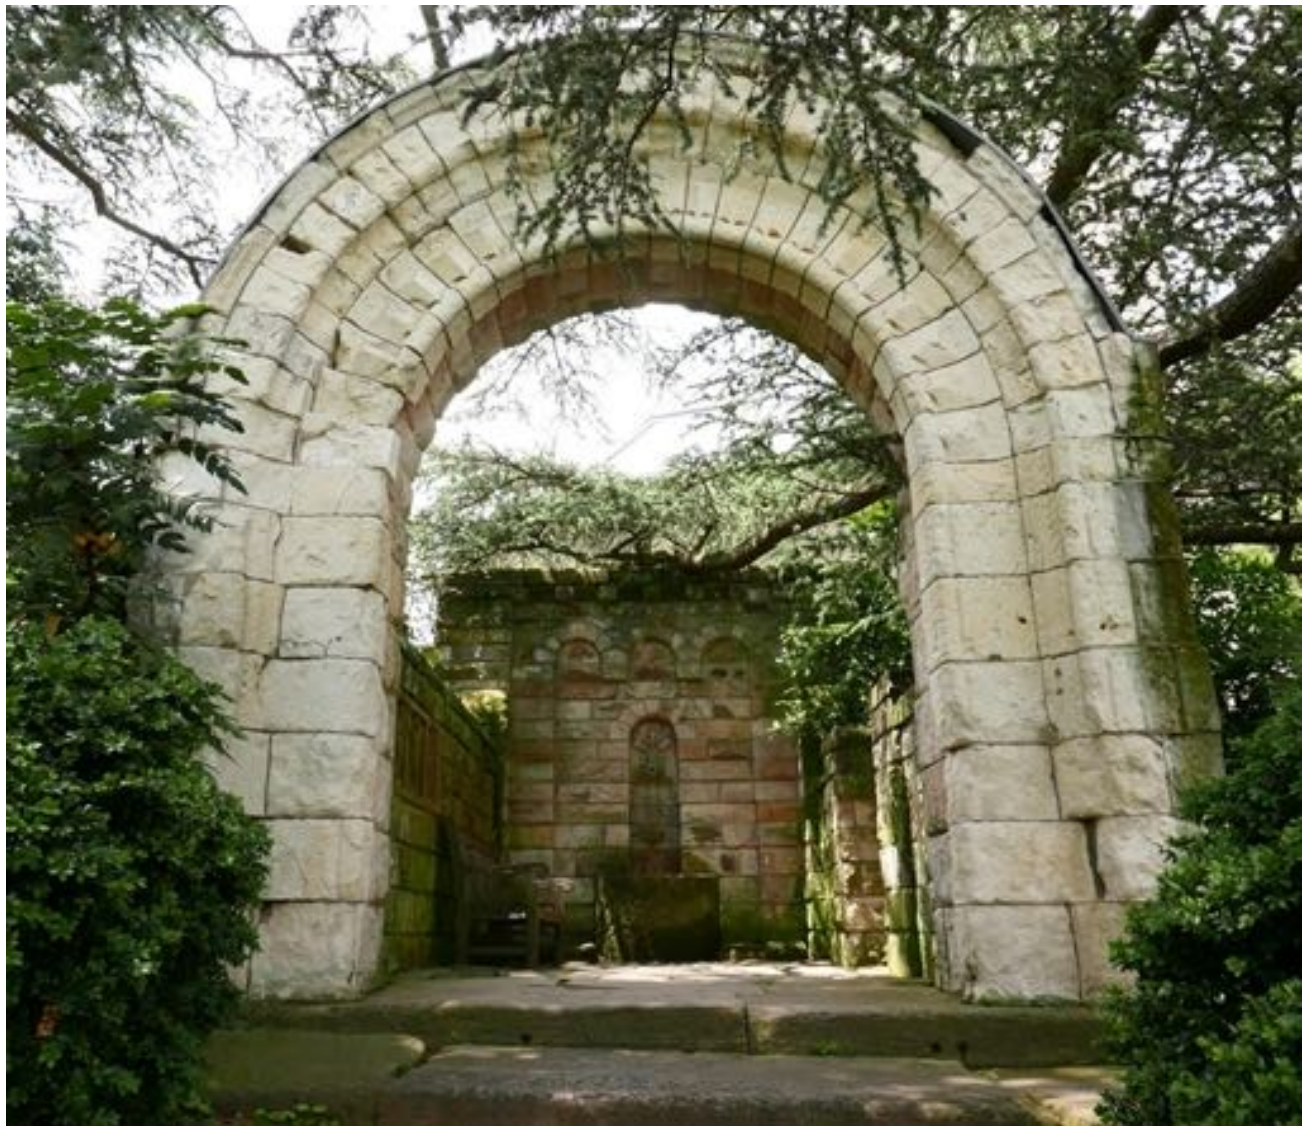
Fig. 1. Norman Arch before the treatment.

The condition of the limestone arch was poor, and the extent of its deterioration was alarming. The decay, caused by the improper pointing mortar and the inherent fragility of the limestone, was widespread and reached deep into the structure of each element. Many elements were showing an irreparable level of deterioration. The stone was powdery and crumbly. The weathering, which included spalling the external layer of the stone, was several inches deep. As a result, most elements have lost their original surface (Fig. 3 and 4). Only a few elements retained their original shape.

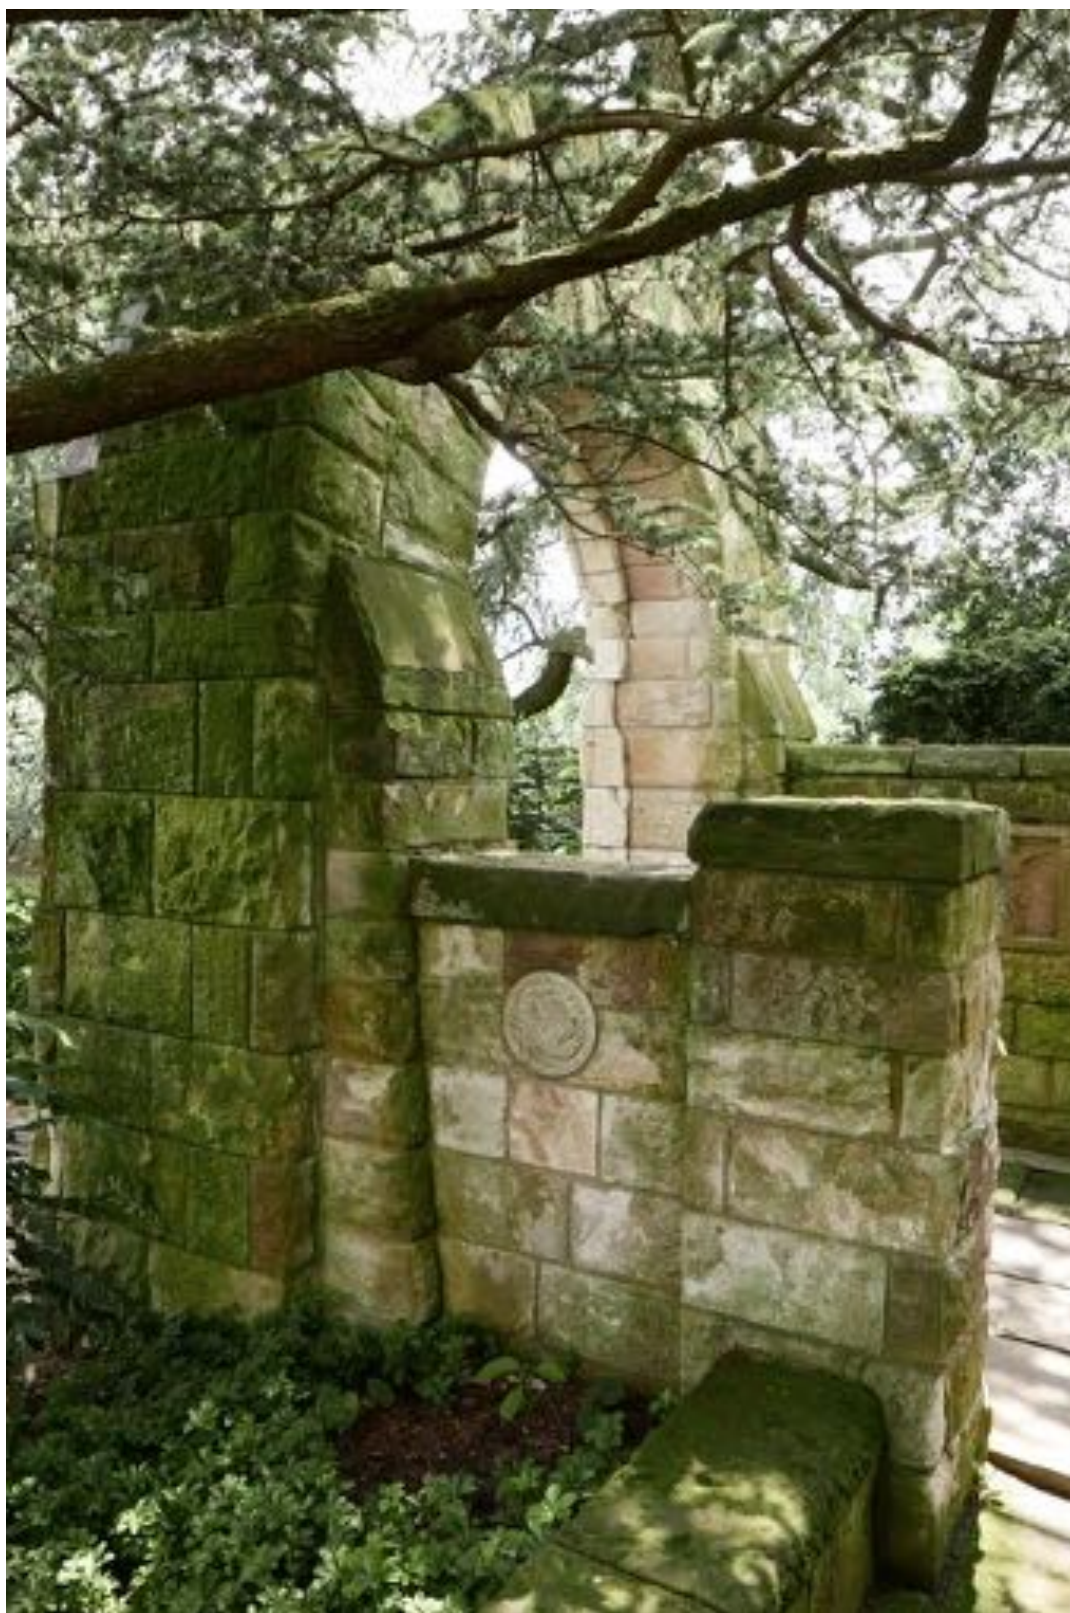
Fig. 2. Norman Court before the conservation treatment.

The walls of the Norman Court are built of sandstone blocks and pointed with cementitious mortar. The condition of the Court is good; however, several harmful factors were contributing to its gradual deterioration. Most of the stone surface was covered with algae, lichen, and moss. The surface of the sandstone blocks appeared severely weathered, particularly in the area above the Thistle Fountain.

1. Cleaning the sandstone structures of the Norman Court, the Thistle Fountain, and the medieval limestone Norman Arch (Images 001-007).

The cleaning was carried out using a hot water pressure washer and a cleaning agent. The successful removal of the biofilm composed of algae, lichen and moss was made possible by applying D/2 (D/2 Biological Solutions) – a masonry detergent and a biocide. The D/2 was applied to the pre-wetted stone and remained on the surface for 10-15 minutes before thorough pressure washing.

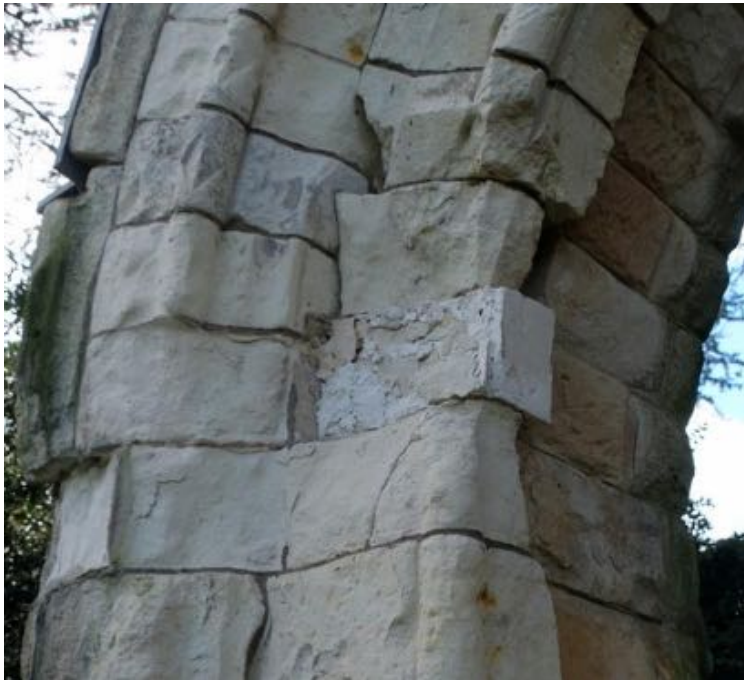
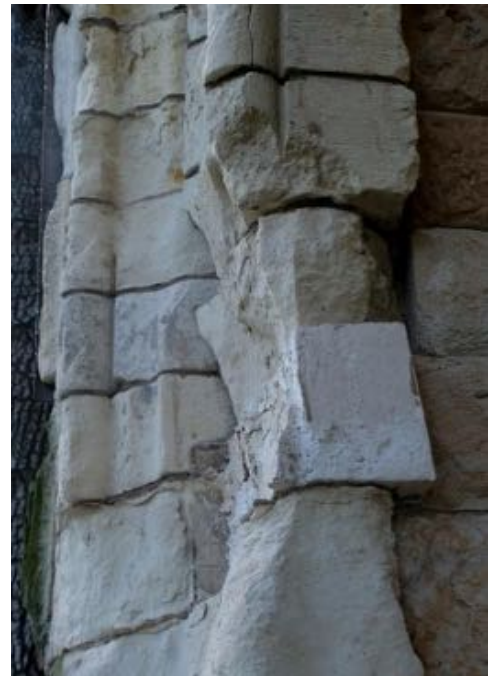
Fig. 3 and 4. Deteriorated blocks of the Norman Arch.

The Norman Arch consists of 110 limestone blocks. Before the treatment, only 20-25 blocks exhibited the original ornaments. Approximately 45 blocks maintained their original shape, yet their surface was heavily weathered. The remaining 65 blocks (representing approximately 60% of the entire Arch) seriously deteriorated and exhibited extensive losses. As many as 38 blocks have lost the entire original surface and a significant part of their original form. Almost all the blocks appeared crumbly and chalky. Many of them exhibited structural cracks and delamination of the external layer.

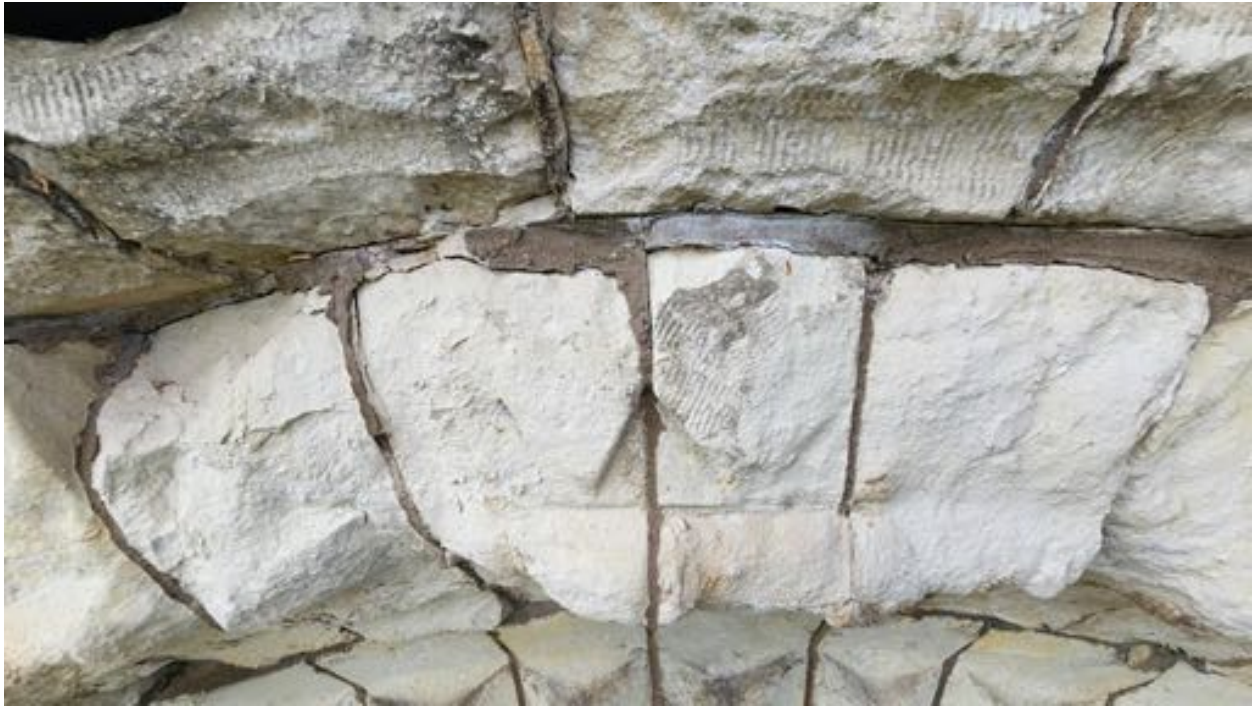
The pointing mortar was a very hard cementitious concrete mix with an extremely high content of cement (Fig. 5). The pattern of the deterioration observed of the limestone elements (recessed surface of the stone blocks and proud, well-preserved joints) is an example of the destructive impact of a wrong choice of pointing mortar. The mortar with these properties does not allow the water to evaporate from the porous structure of the stone and contributes to its accelerated deterioration caused by freeze-thaw cycles.

Fig. 5. The fragment of the Norman Arch. Old and extremely hard cementitious pointing mortar before it was removed from the joints of the Arch.

2. Diamond cutting and removal of the old, faulty pointing mortar from the limestone portion of the Arch.

The old cementitious mortar was cut with diamond discs mounted on angle grinders. The mortar was extremely hard and very well adhered to the limestone. The joints were cut and carefully chiseled out using tungsten chisels. The debris was removed from the joints by blowing it out with compressed air and flushing it out with water.

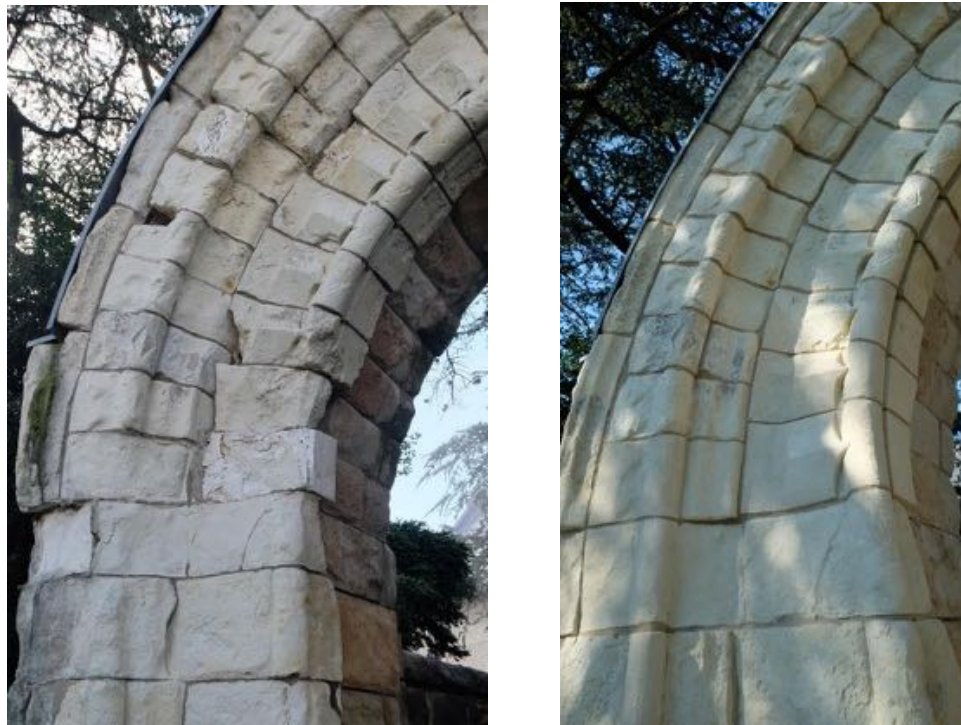
Fig. 5. A badly damaged section of the Arch before and after the treatment.

The losses and the missing elements were recreated using a high-quality restoration mortar JAHN M70 (Cathedral Stone Products). The mortar used for fills was custom color matched by Cathedral Stone Products color lab. These two base shades and their combinations were used to match the color of the original stone (Images 015 and 016). Several elements of the Arch were a total loss and were recreated entirely (Images 017 and 018).

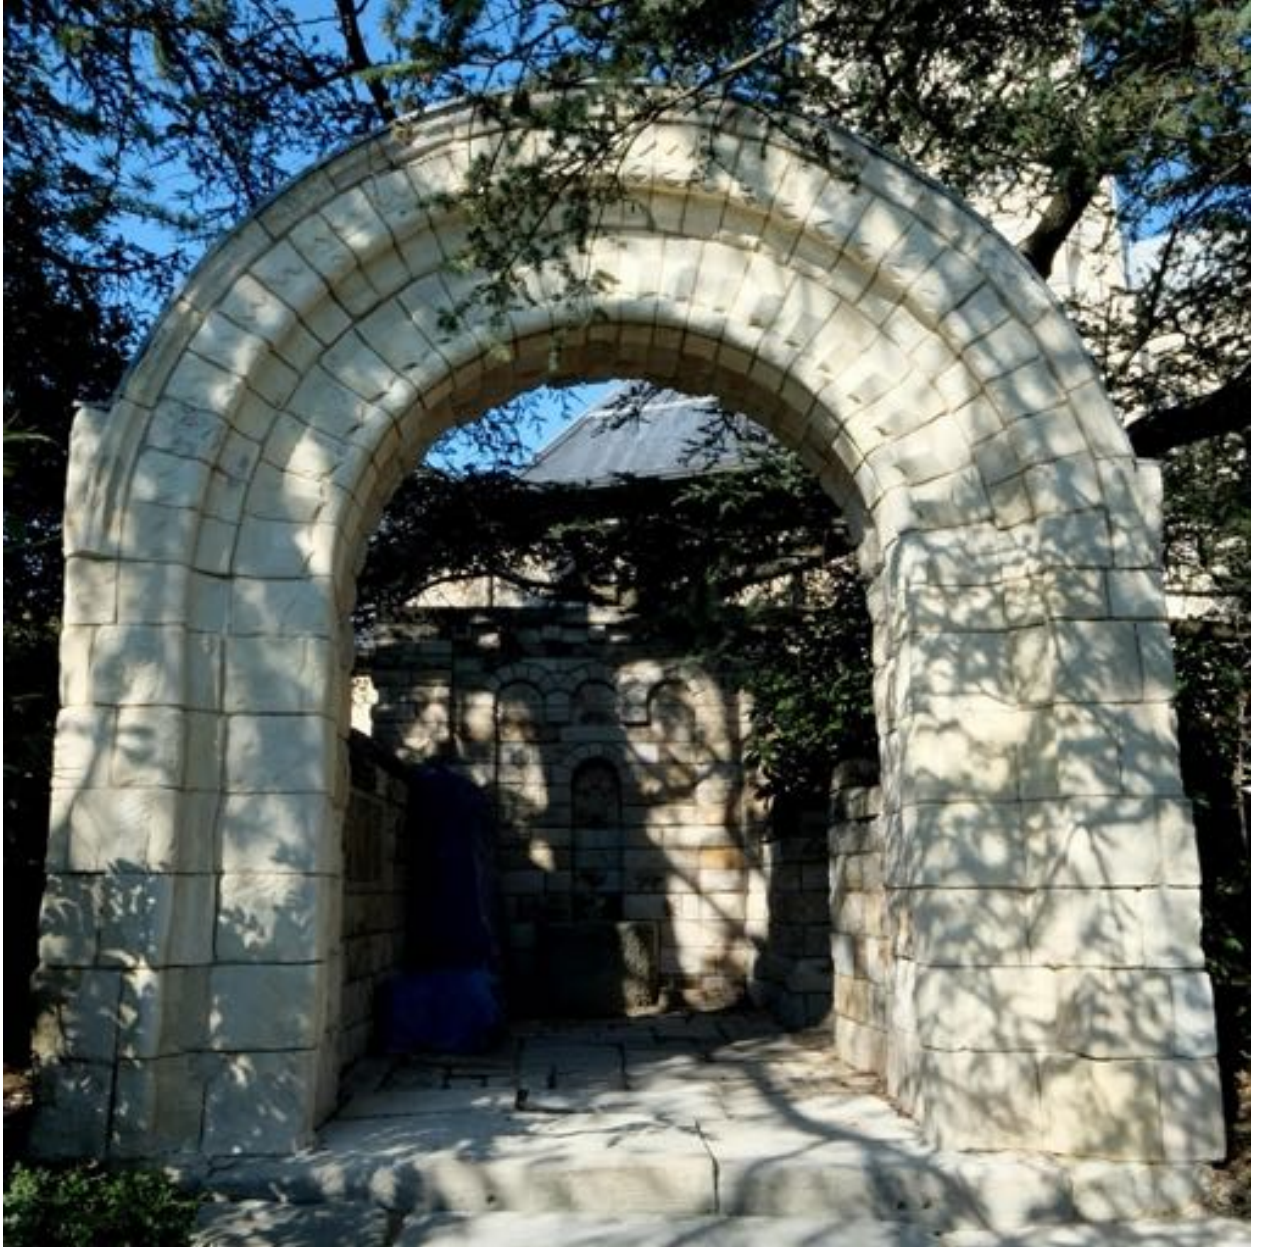
Fig. 6. The Norman Arch after the treatment.

The joints in the limestone portion of the Arch were re-pointed with the restoration grade mortar CONPROCO RePoint O-type (Images 019-024).

An additional consolidative treatment is recommended to protect the delicate historic limestone arch after its conservation-restoration. The limestone elements and the newly installed fills should be protected against the adverse effects of water by treating these areas with PROSOCO Conservare H100, a product that (apart from its strengthening properties) is used as a water repellent. A treatment (similar to the recent consolidation with PROSOCO Conservare OH100) should be carried out in the nearest future to minimize the water infiltration. A proposal for such treatment can be provided.
