The Next Phase of Stonework Conservation

Stone Conservation in the Bishop's Garden

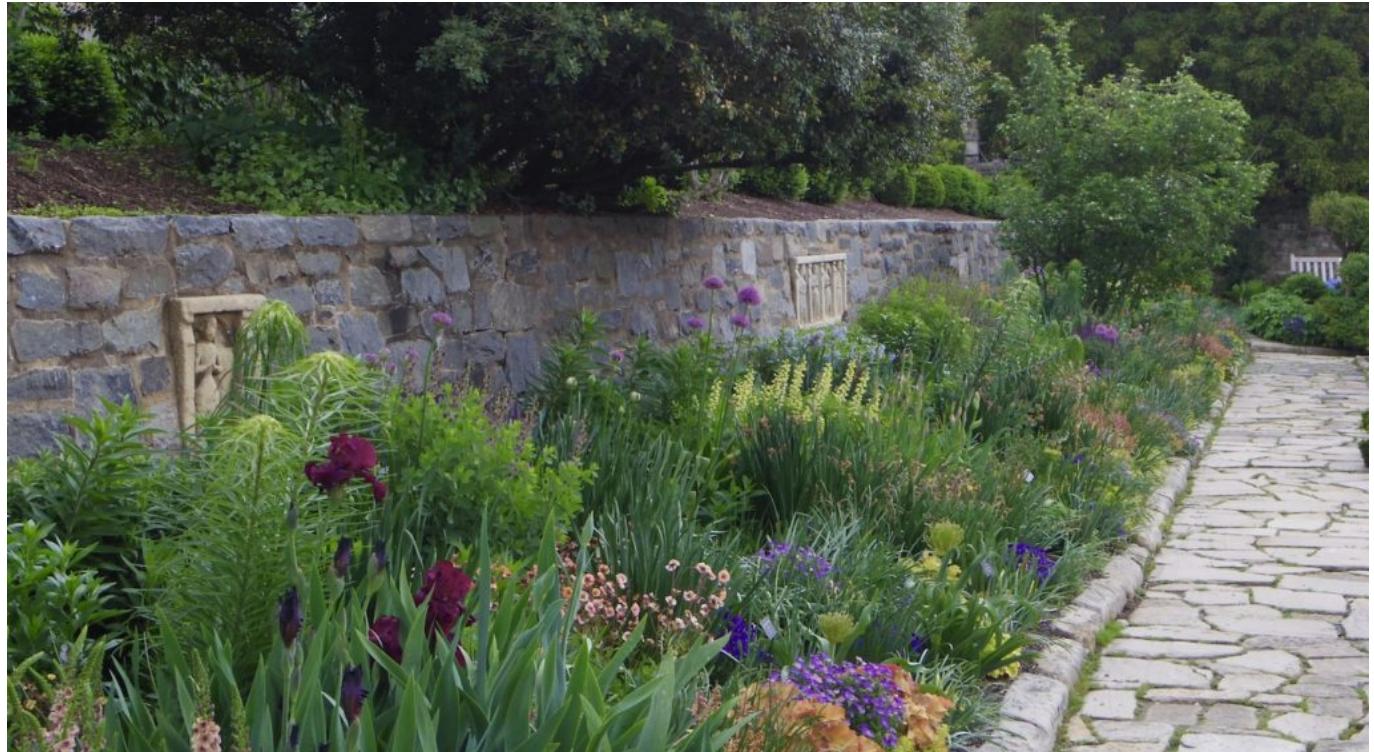
Bas relief panels in the upper wall of the Bishop's Garden

Medieval sculpture serve as focal points and backdrops to the Bishop's Garden's plantings. The garden was completed in 1928, and in 2013 it was rededicated following a major restoration and replanting. In 2018 All Hallows Guild began to address the preservation of the Bishop's Garden's Medieval stonework – which displayed significant deterioration due to decades of exposure to the elements.

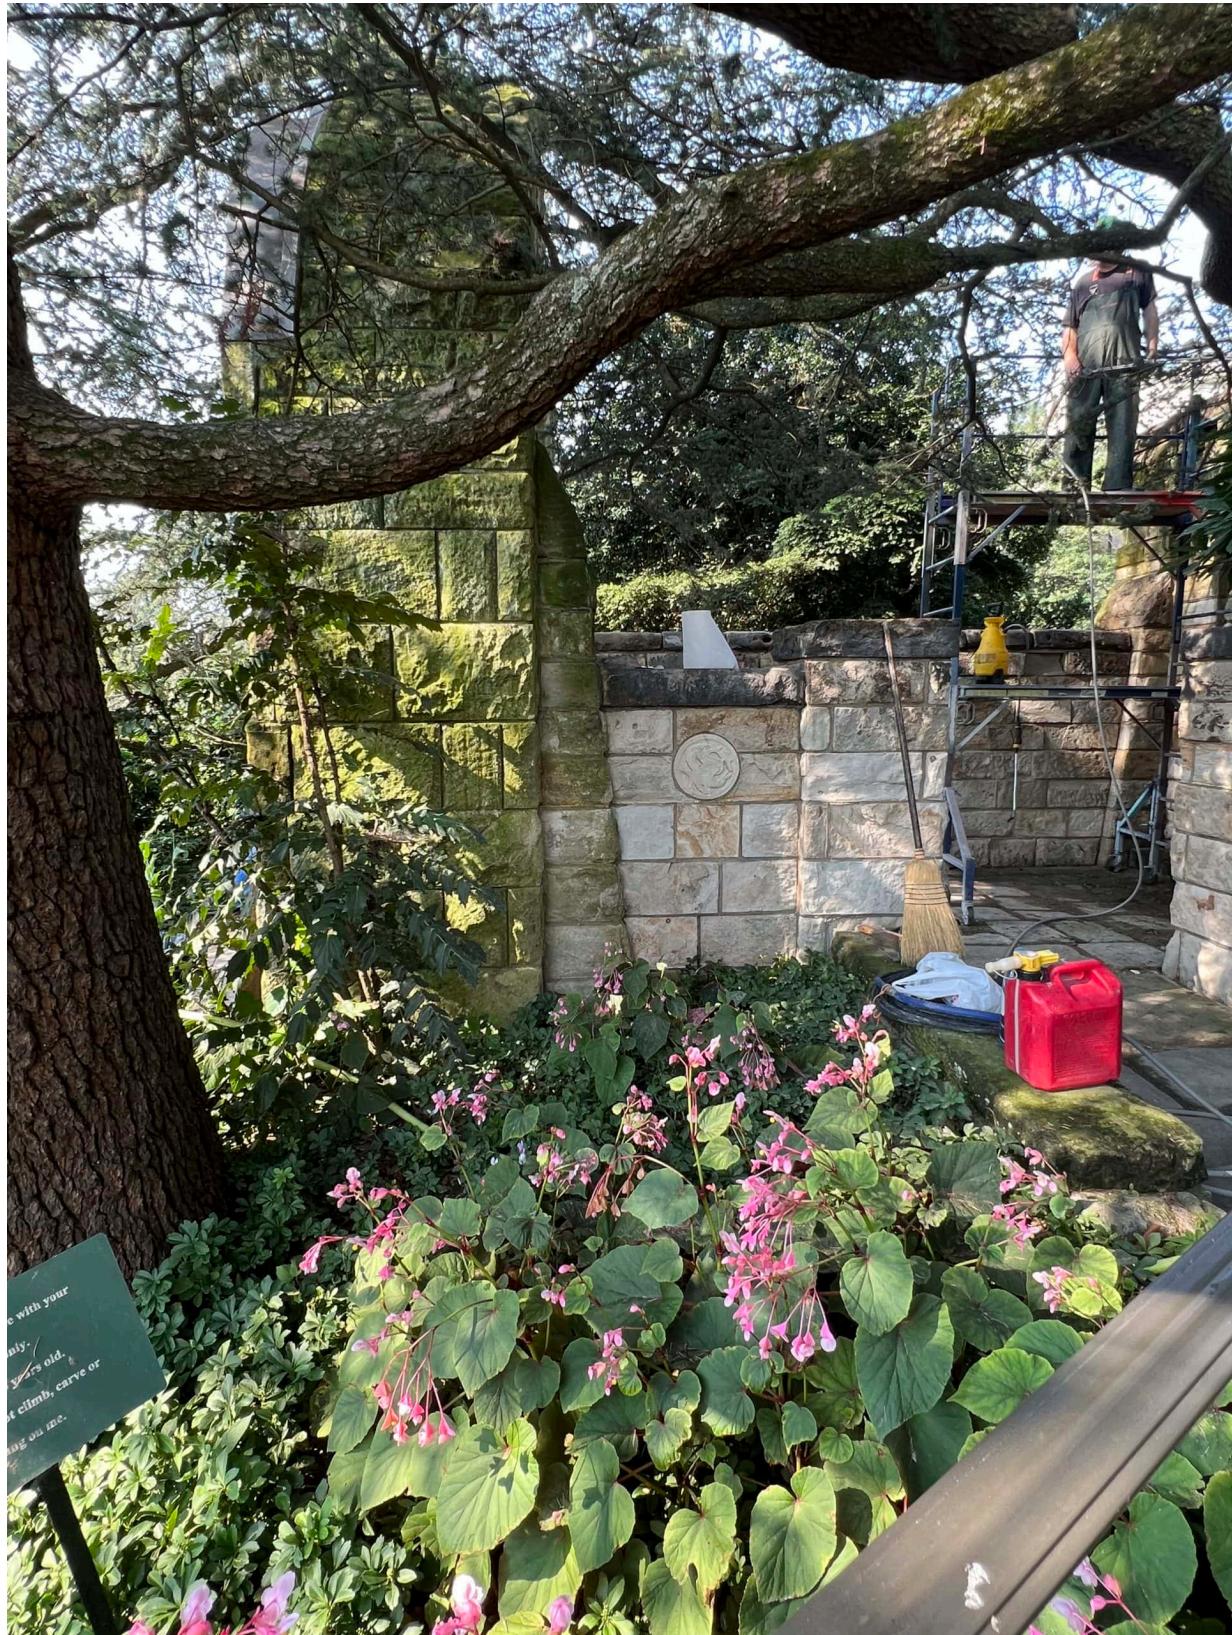
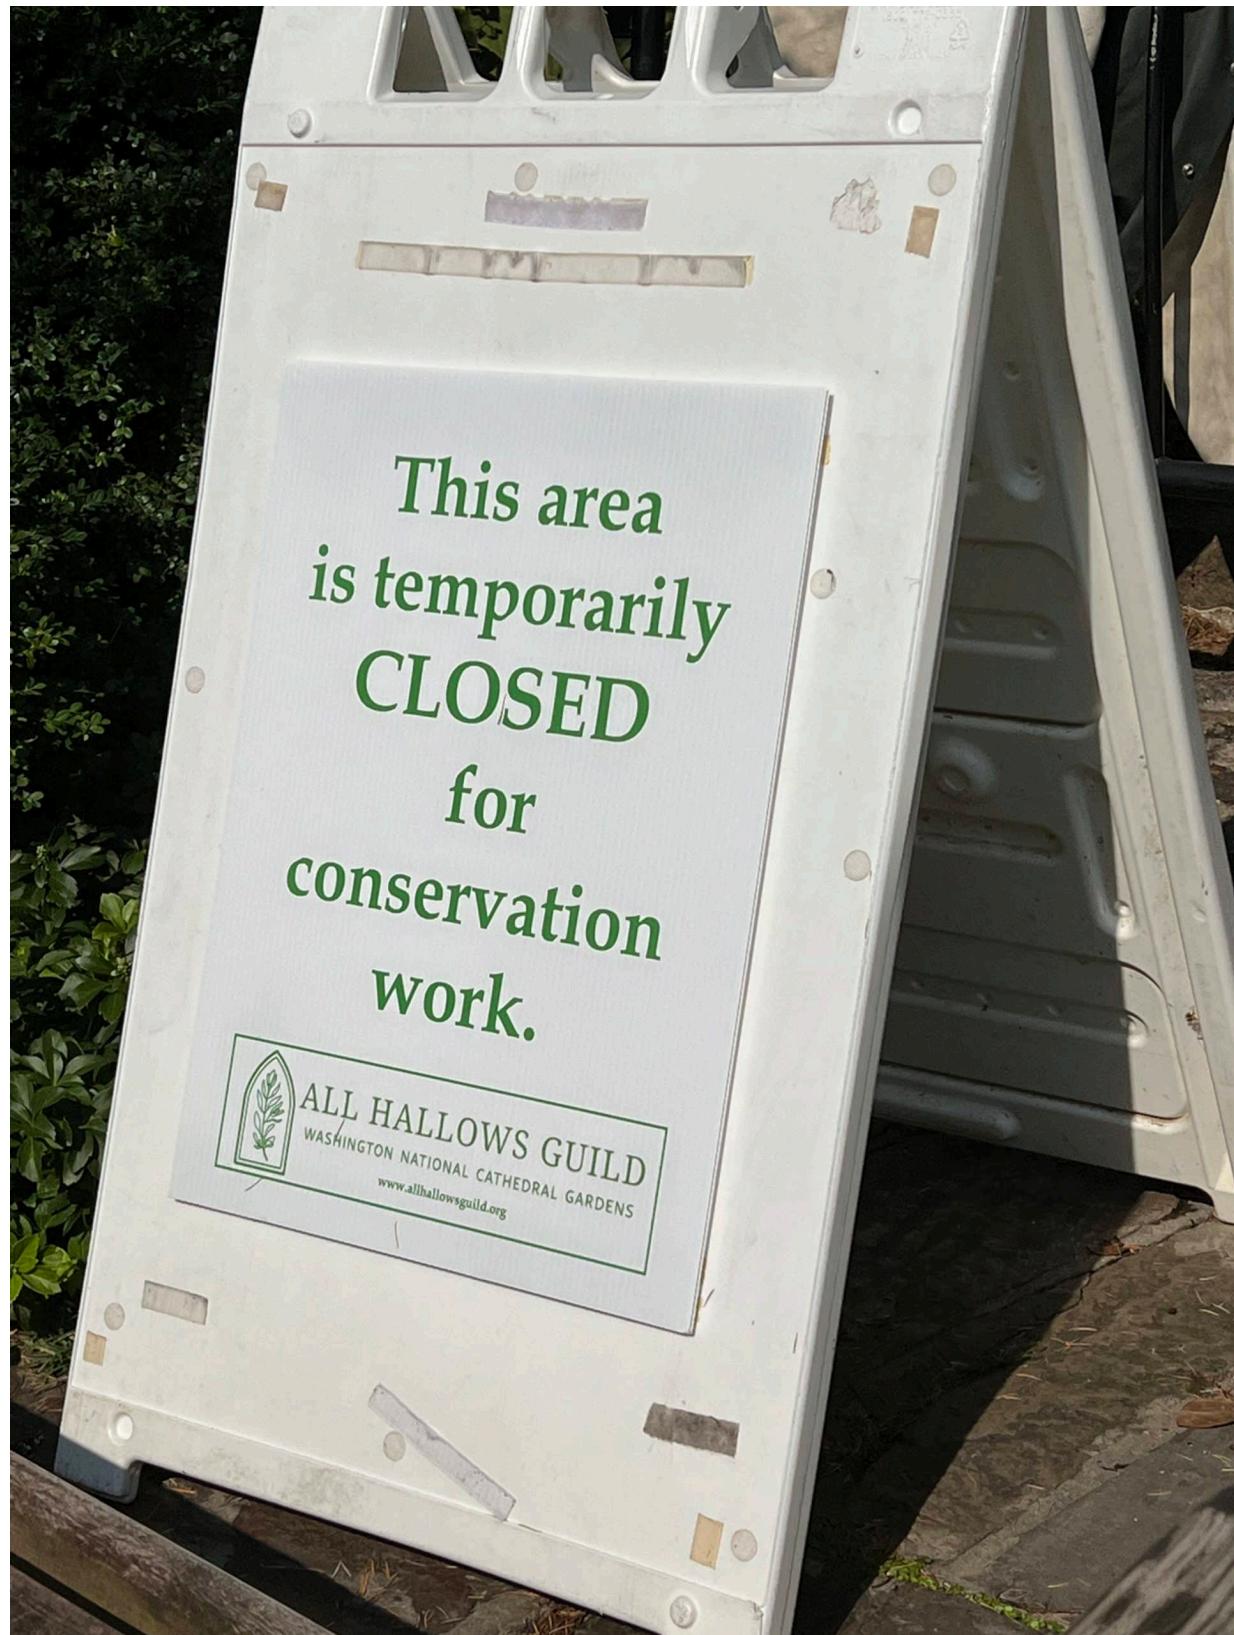
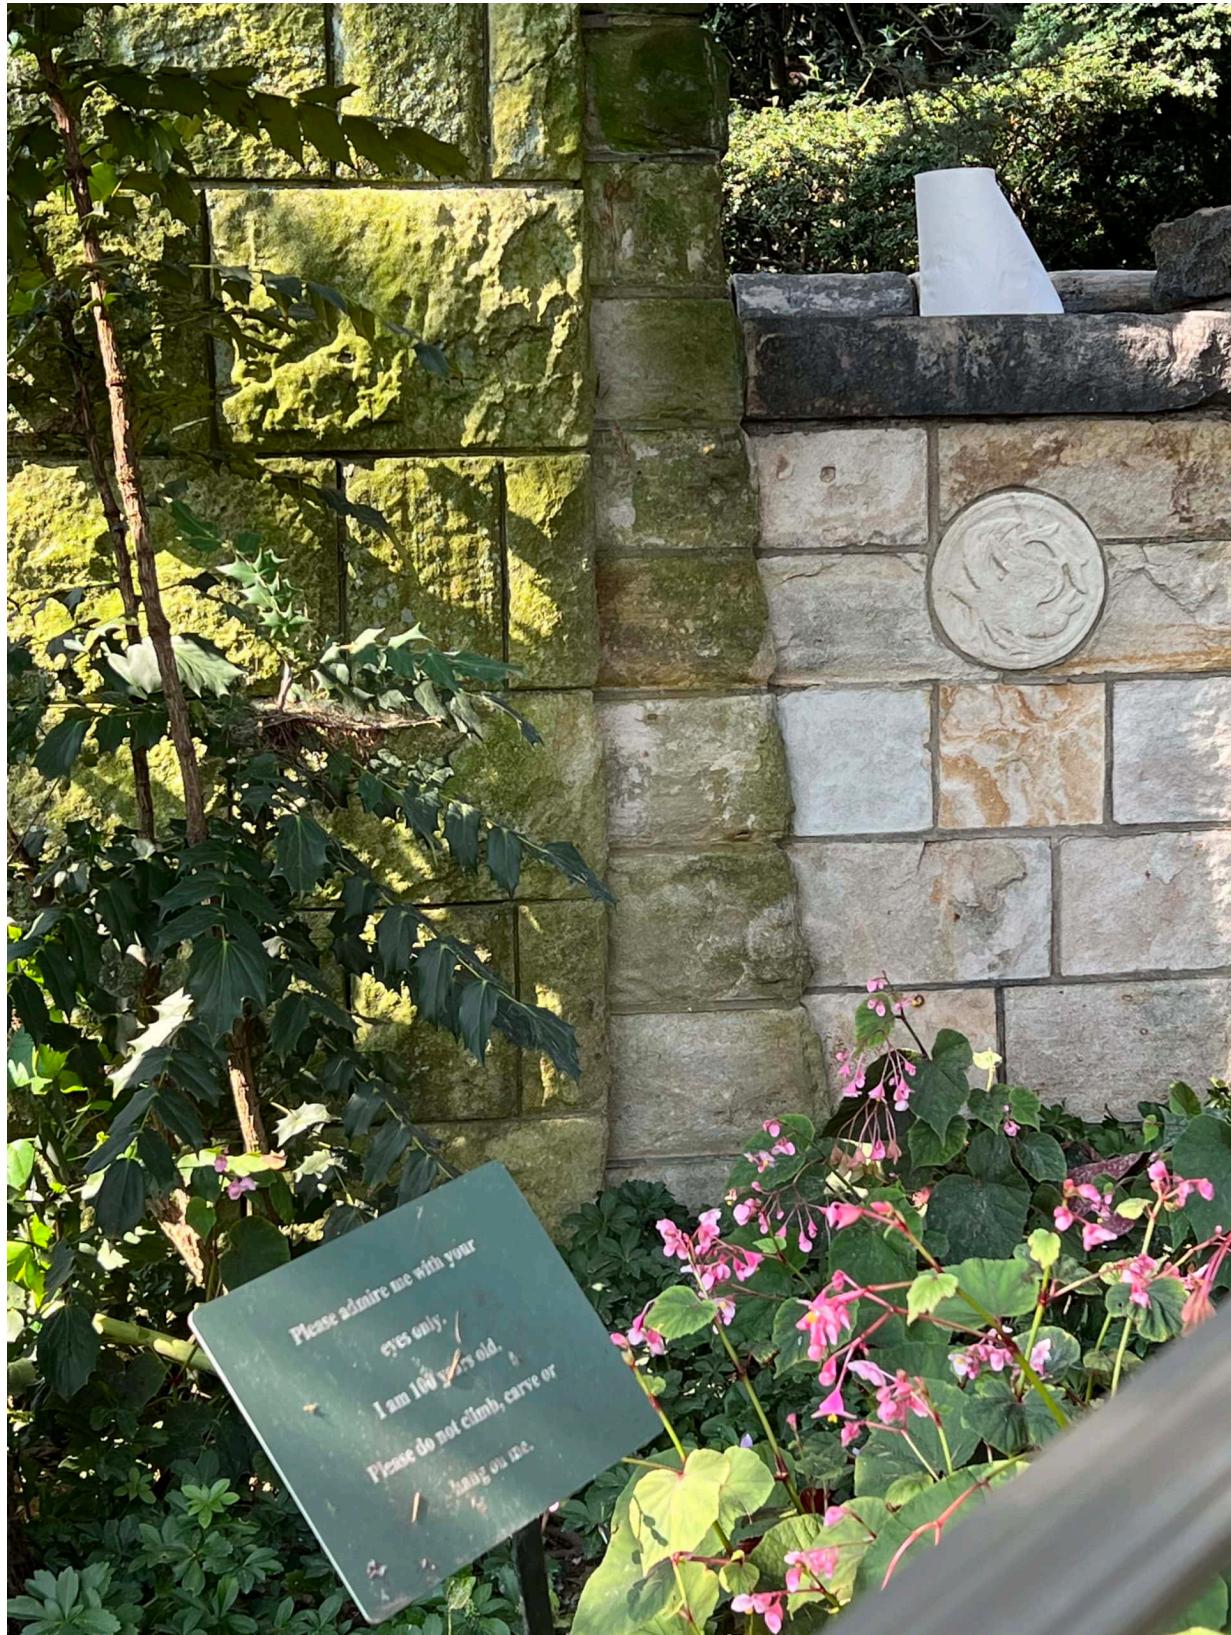
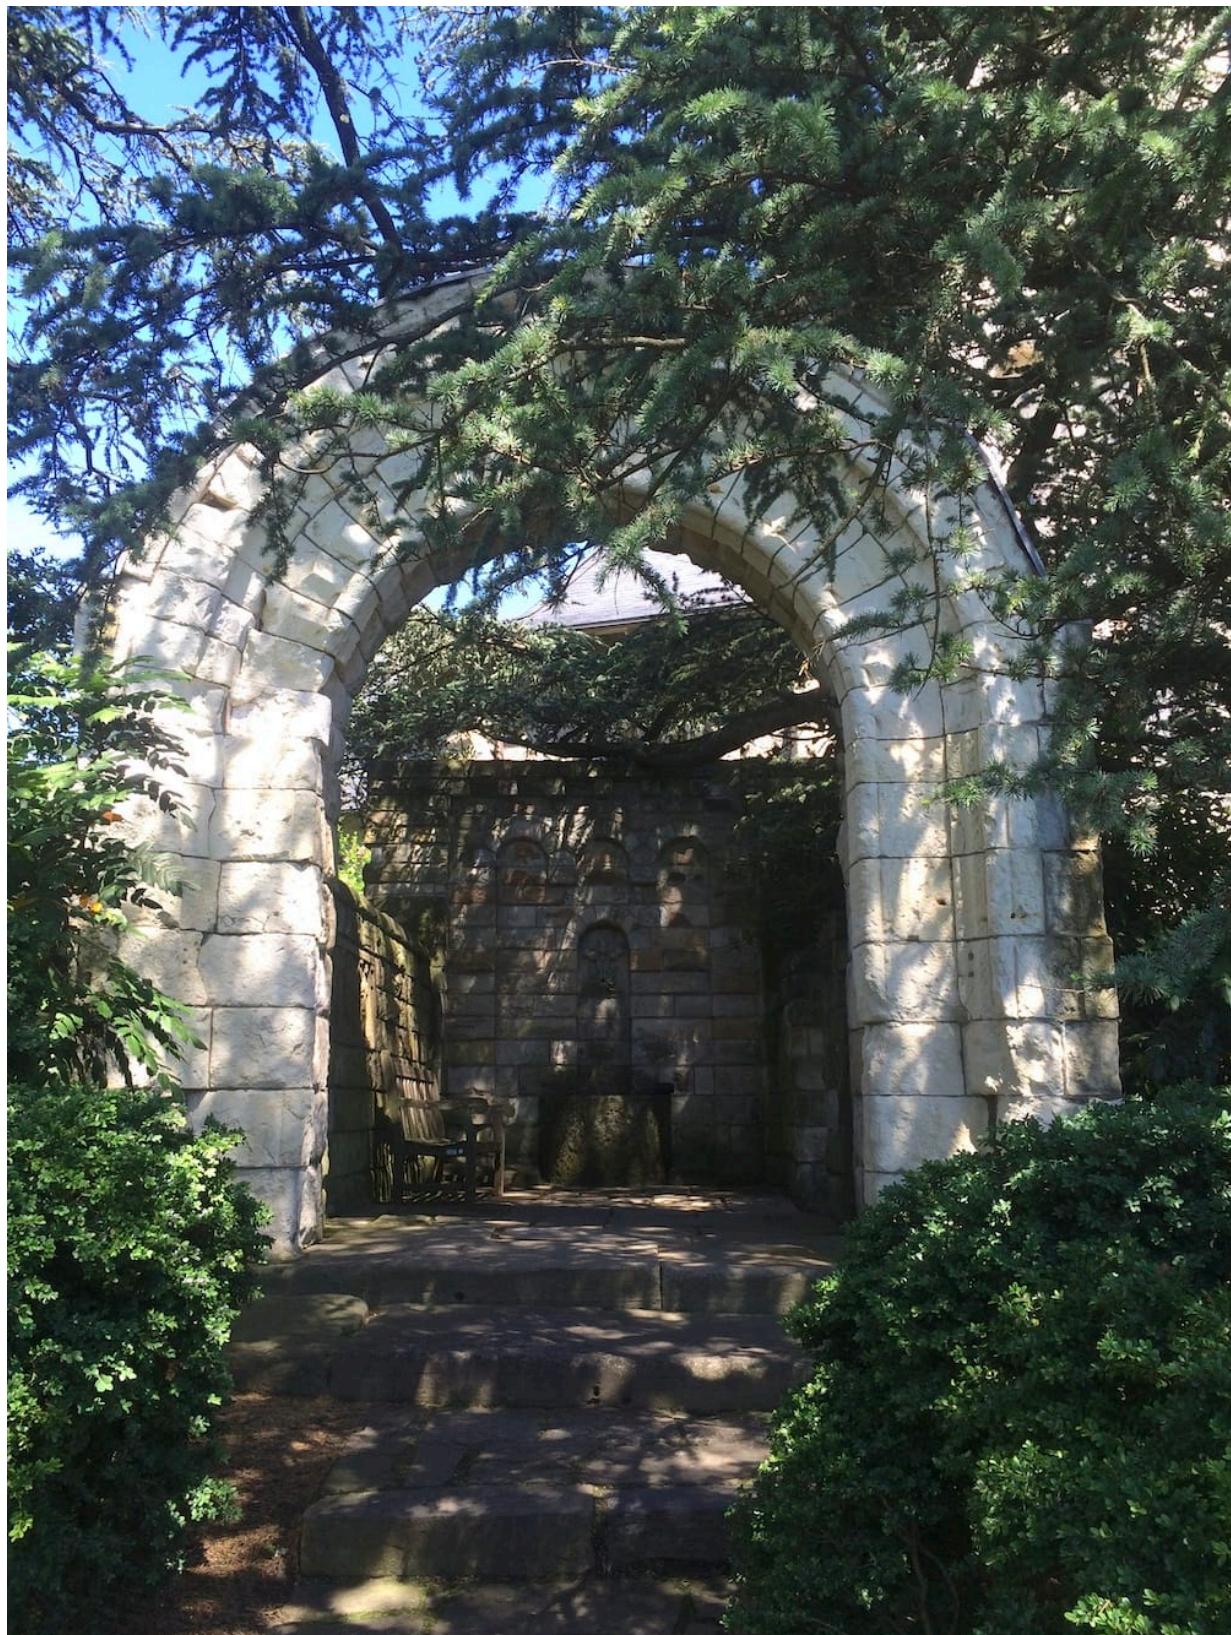
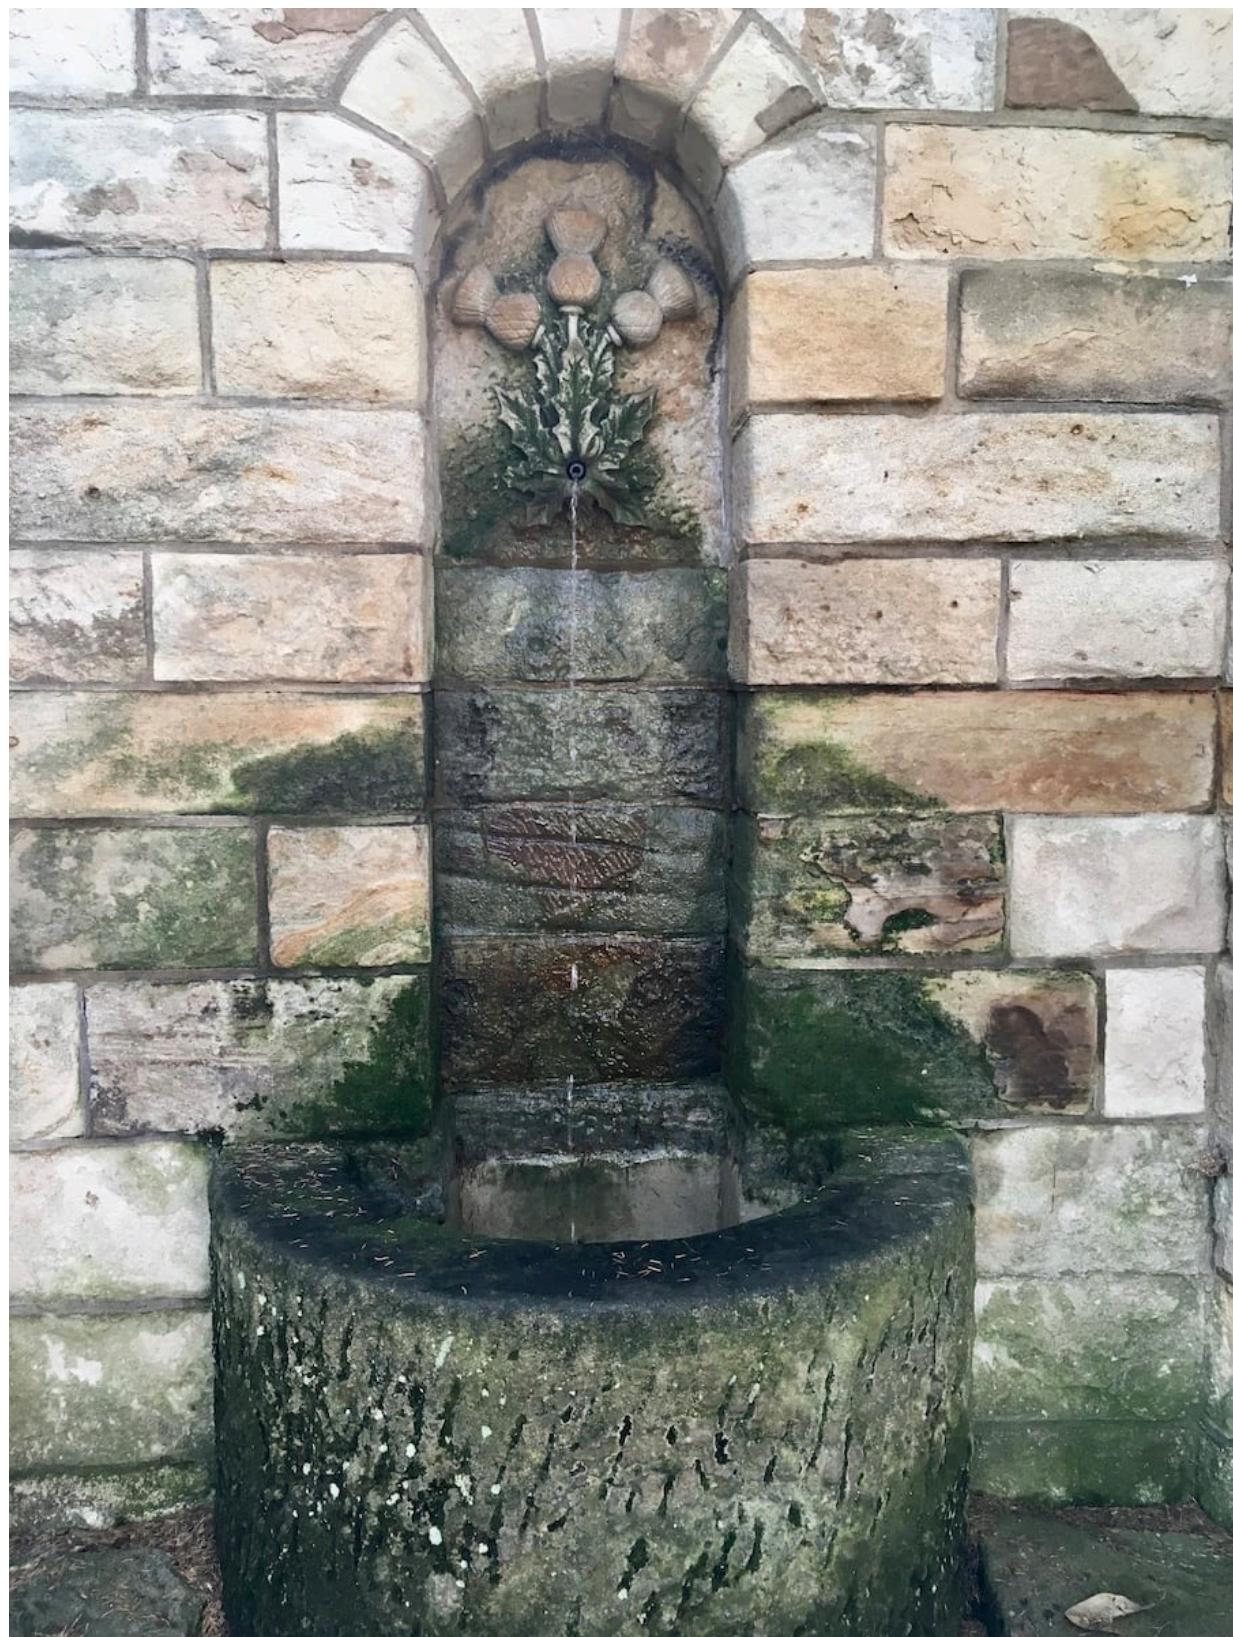
Conservation and cleaning have the Norman Court temporarily closed

The focus of the latest phase of stonework conservation will be the Bishop's Garden's Norman Court and Norman Arch. All Hallows Guild has engaged McKay Lodge Laboratory, specialists in Fine Art Conservation. They commenced work on Wednesday, September 14, 2022 and it is anticipated to continue through late October under the direction of Marcin Pikus of McKay Lodge.

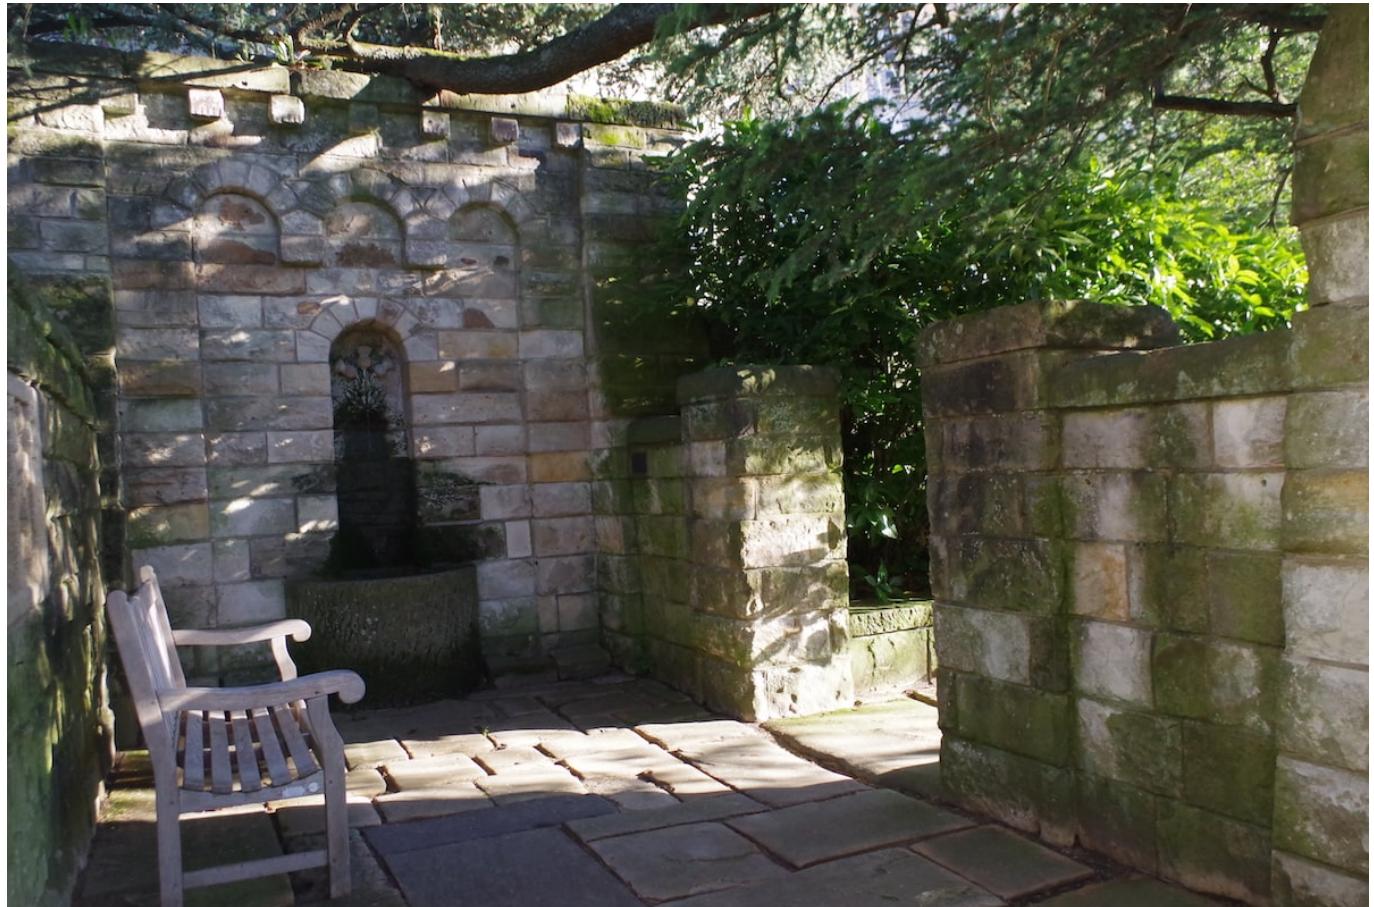
The Norman Act and Court prior to conservation work

The Norman Court was designed by Florence Bratenahl and completed in 1928. The Norman arch, from a 12th century ruined monastery in France, is made of Caen limestone. The arch, along with the 15th century bas-relief inside the court, were acquired from the collection of George Grey Barnard, whose collection formed the basis of the Metropolitan Museum of Art's Cloisters in New York City.

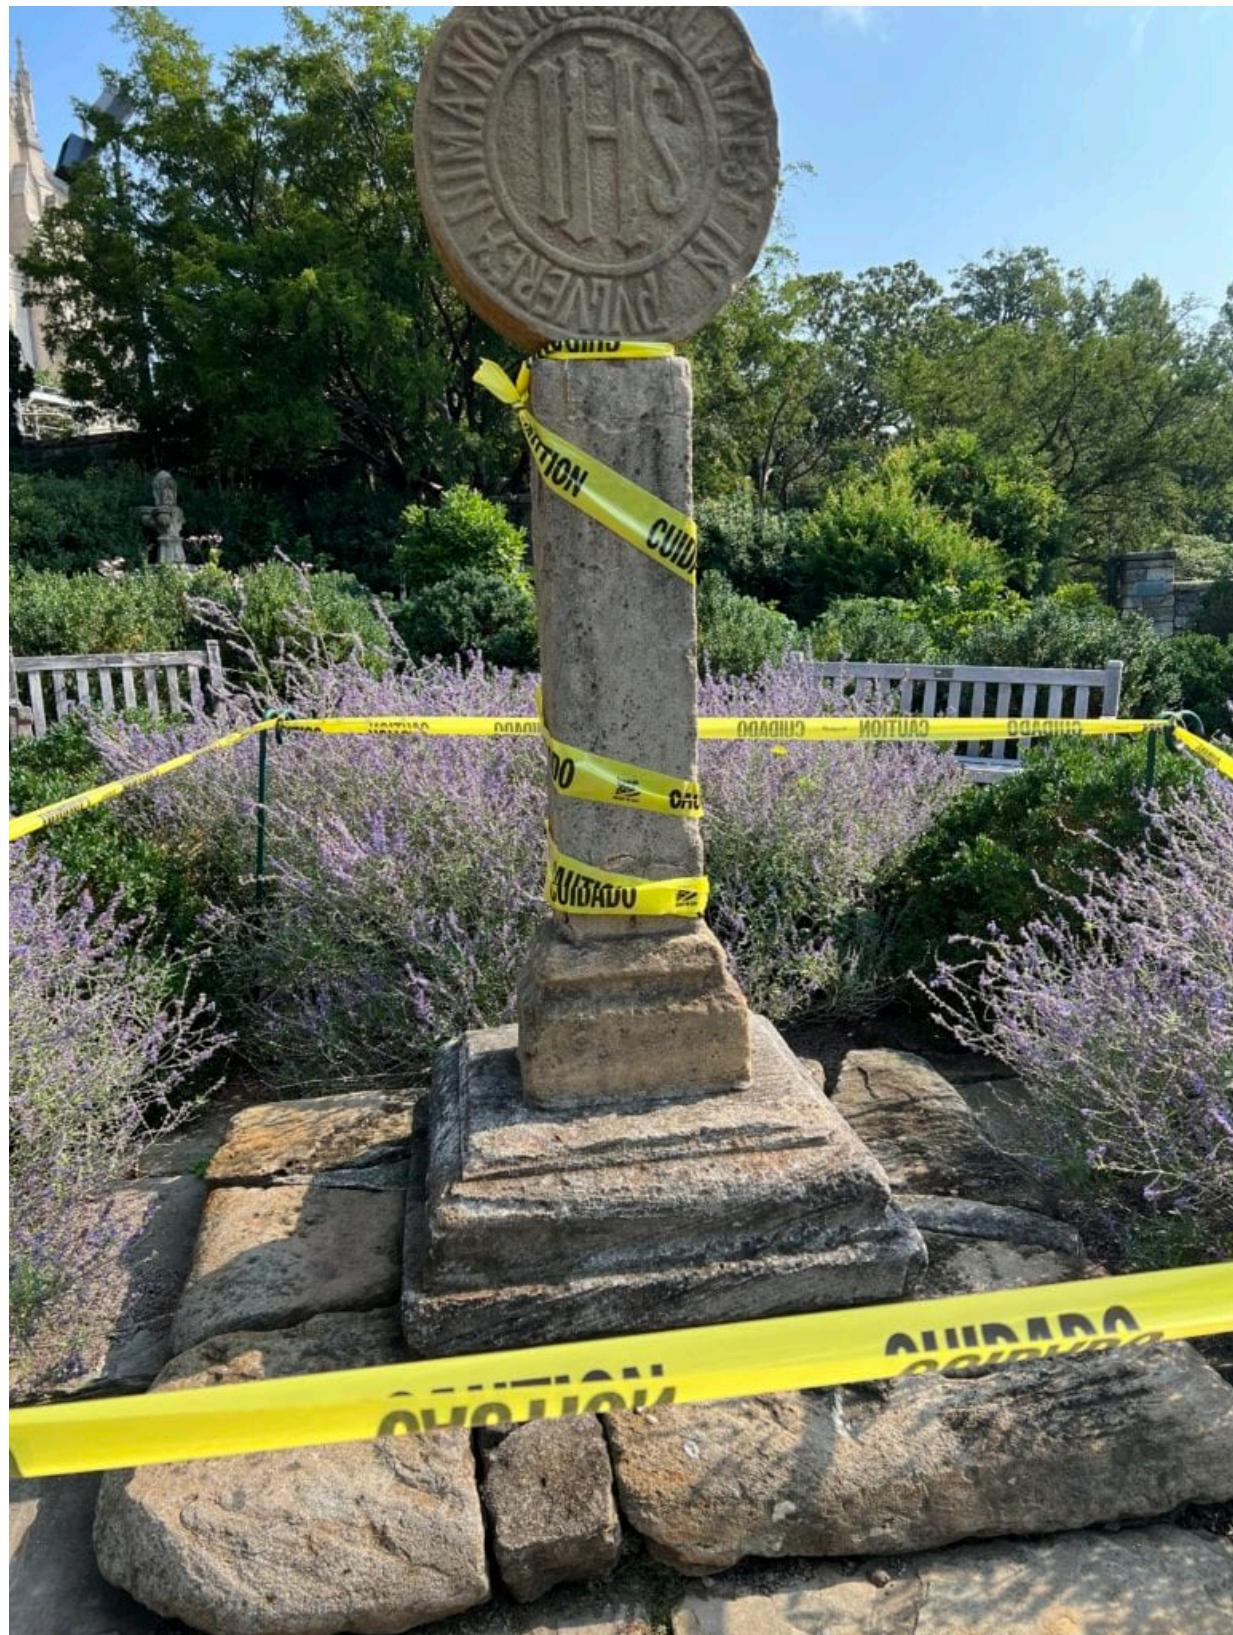
The Wayside Cross was damaged due to vandalism

On Wednesday, September 14, 2022 the Cathedral's Mason Foreman, Joe Alonso and Marcin Pikus of McKay Lodge met to assess damage discovered on the Wayside Cross – which stands near the center of the Bishop's Garden. They determined that the stone cross had suffered from vandalism – with significant cracking near the base. Temporary protection and stabilization has been installed around the cross. It will remain in the garden until later in September when the Cathedral's stonemasons will transport it to their workspace. It is fortunate that we have the expertise of our stonemasons and conservationists at hand and that the damage was discovered before more destruction occurred.

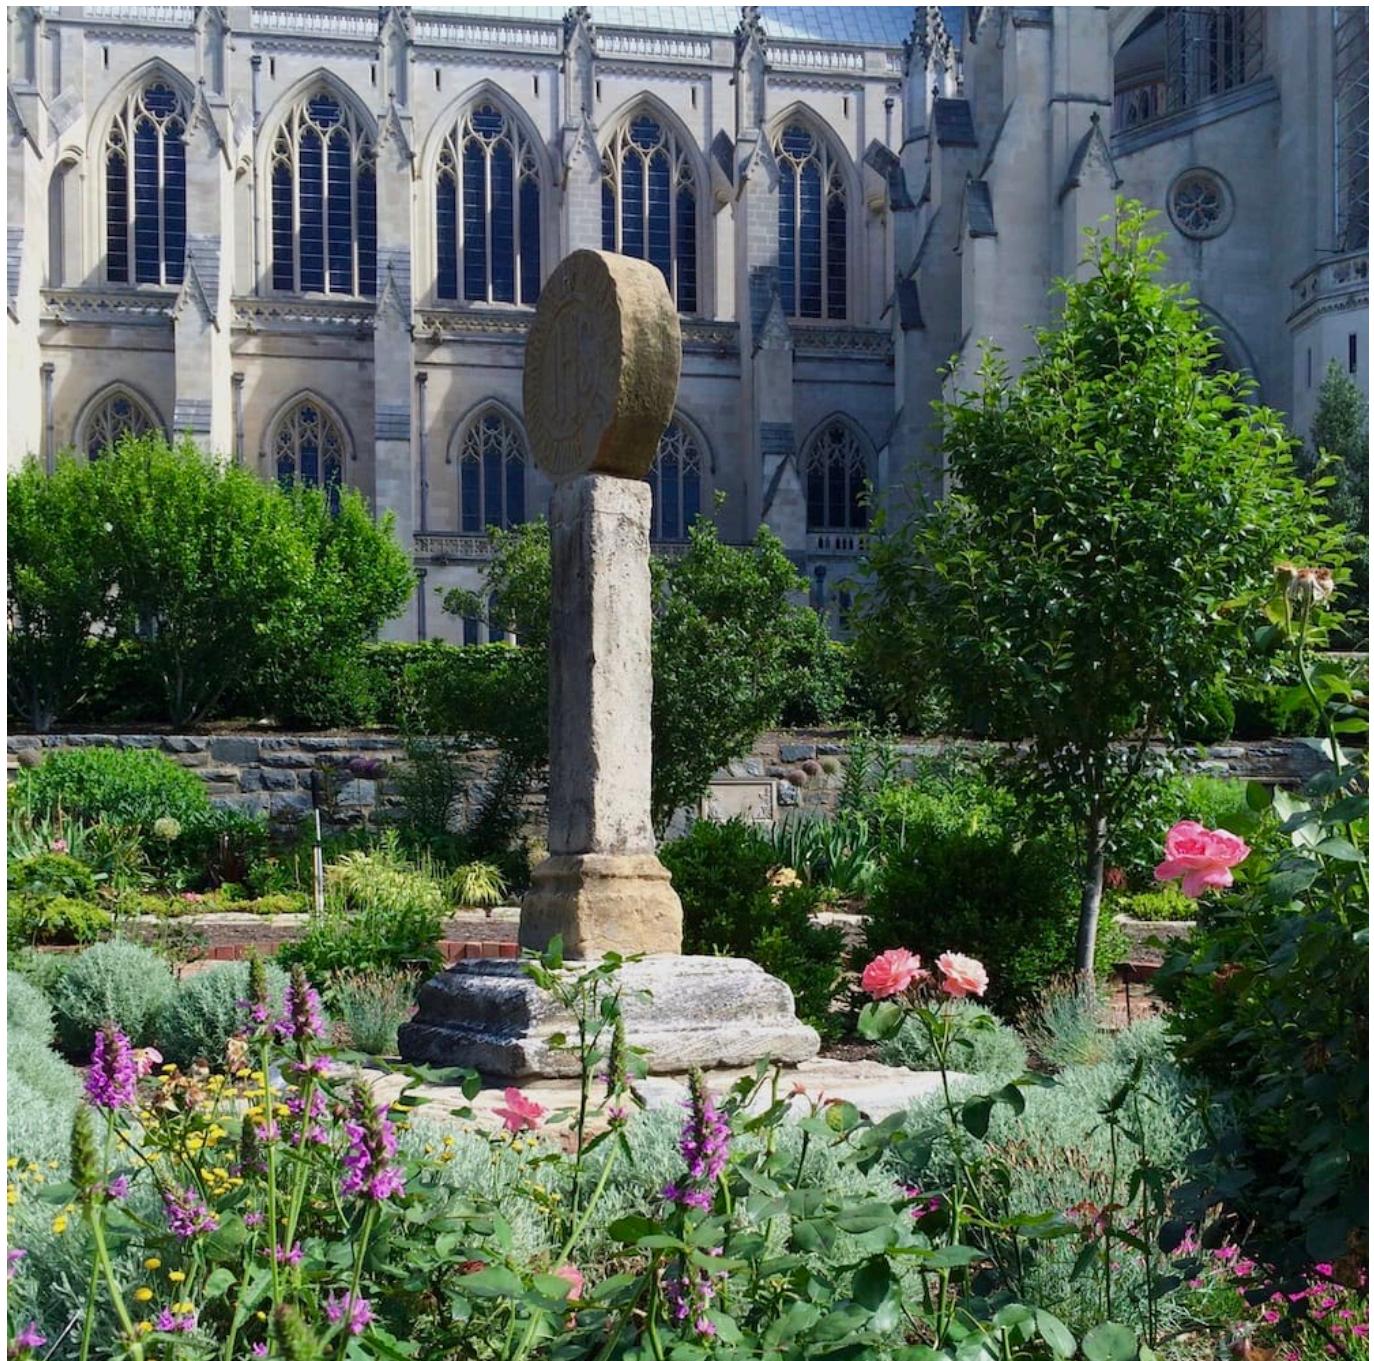
The Wayside Cross in 2020

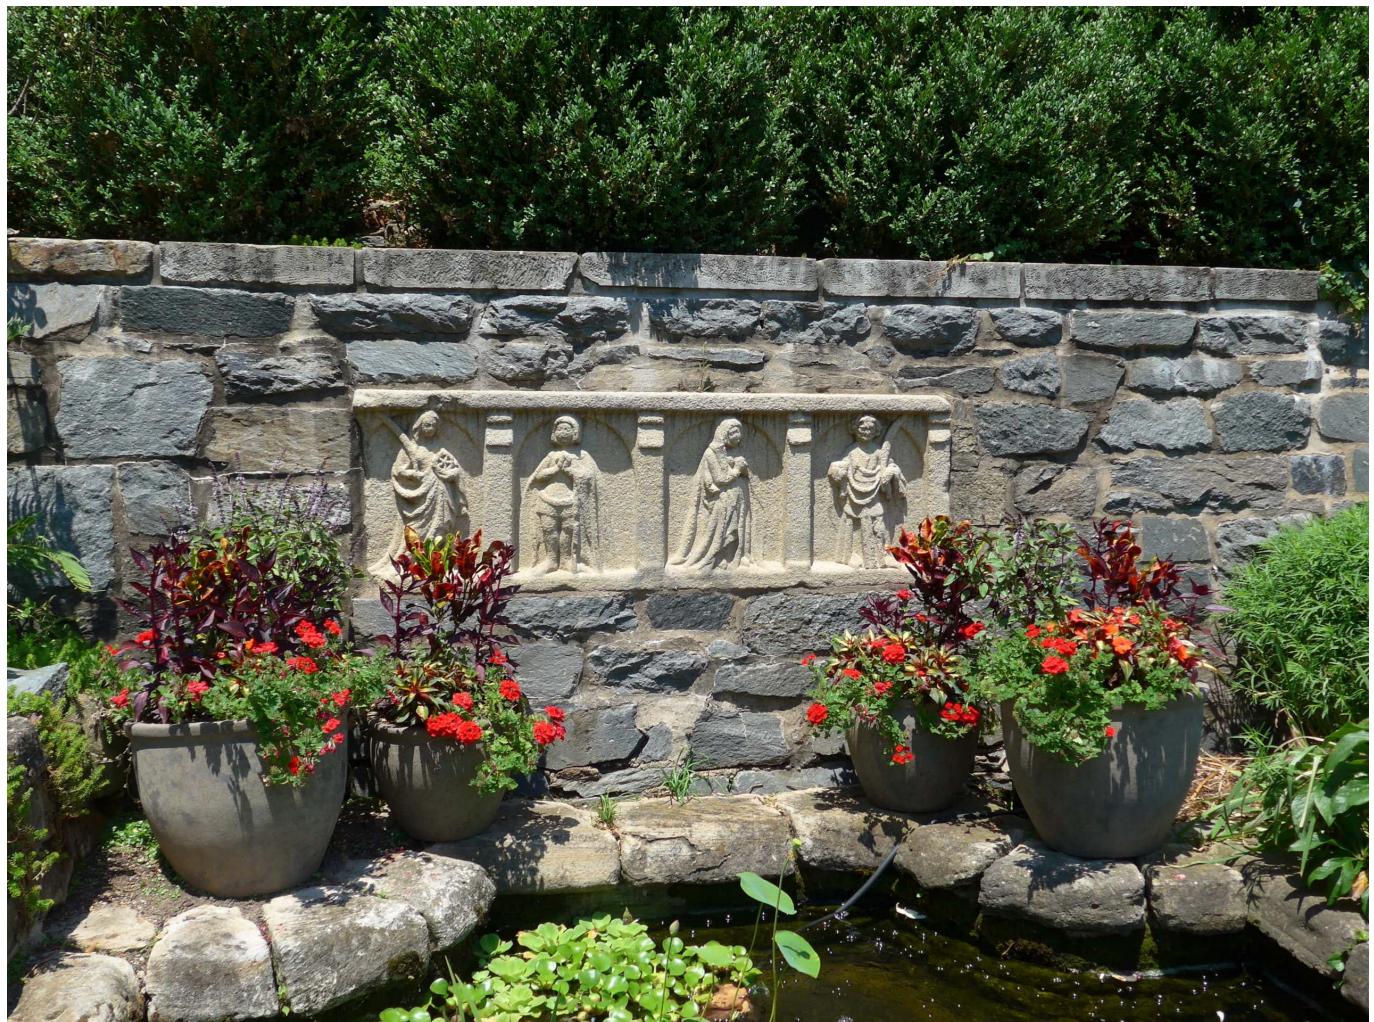
The conservation work done in October 2018 included five granite bas relief panels and the Carolingian Baptismal Font. McKay Lodge assessed the condition of

the reliefs as fair to poor with degradation of the original surface and the details of the carvings reduced due to water, changing thermal conditions, and microbiological growth. The condition of the Font was also poor with a considerable degree of deterioration. Following the conservation work the artifacts were not only improved in their appearance, but also stabilized and guarded from on-going decay. If you would like to read more about the 2018 stonework restoration [**CLICK HERE.**](#)

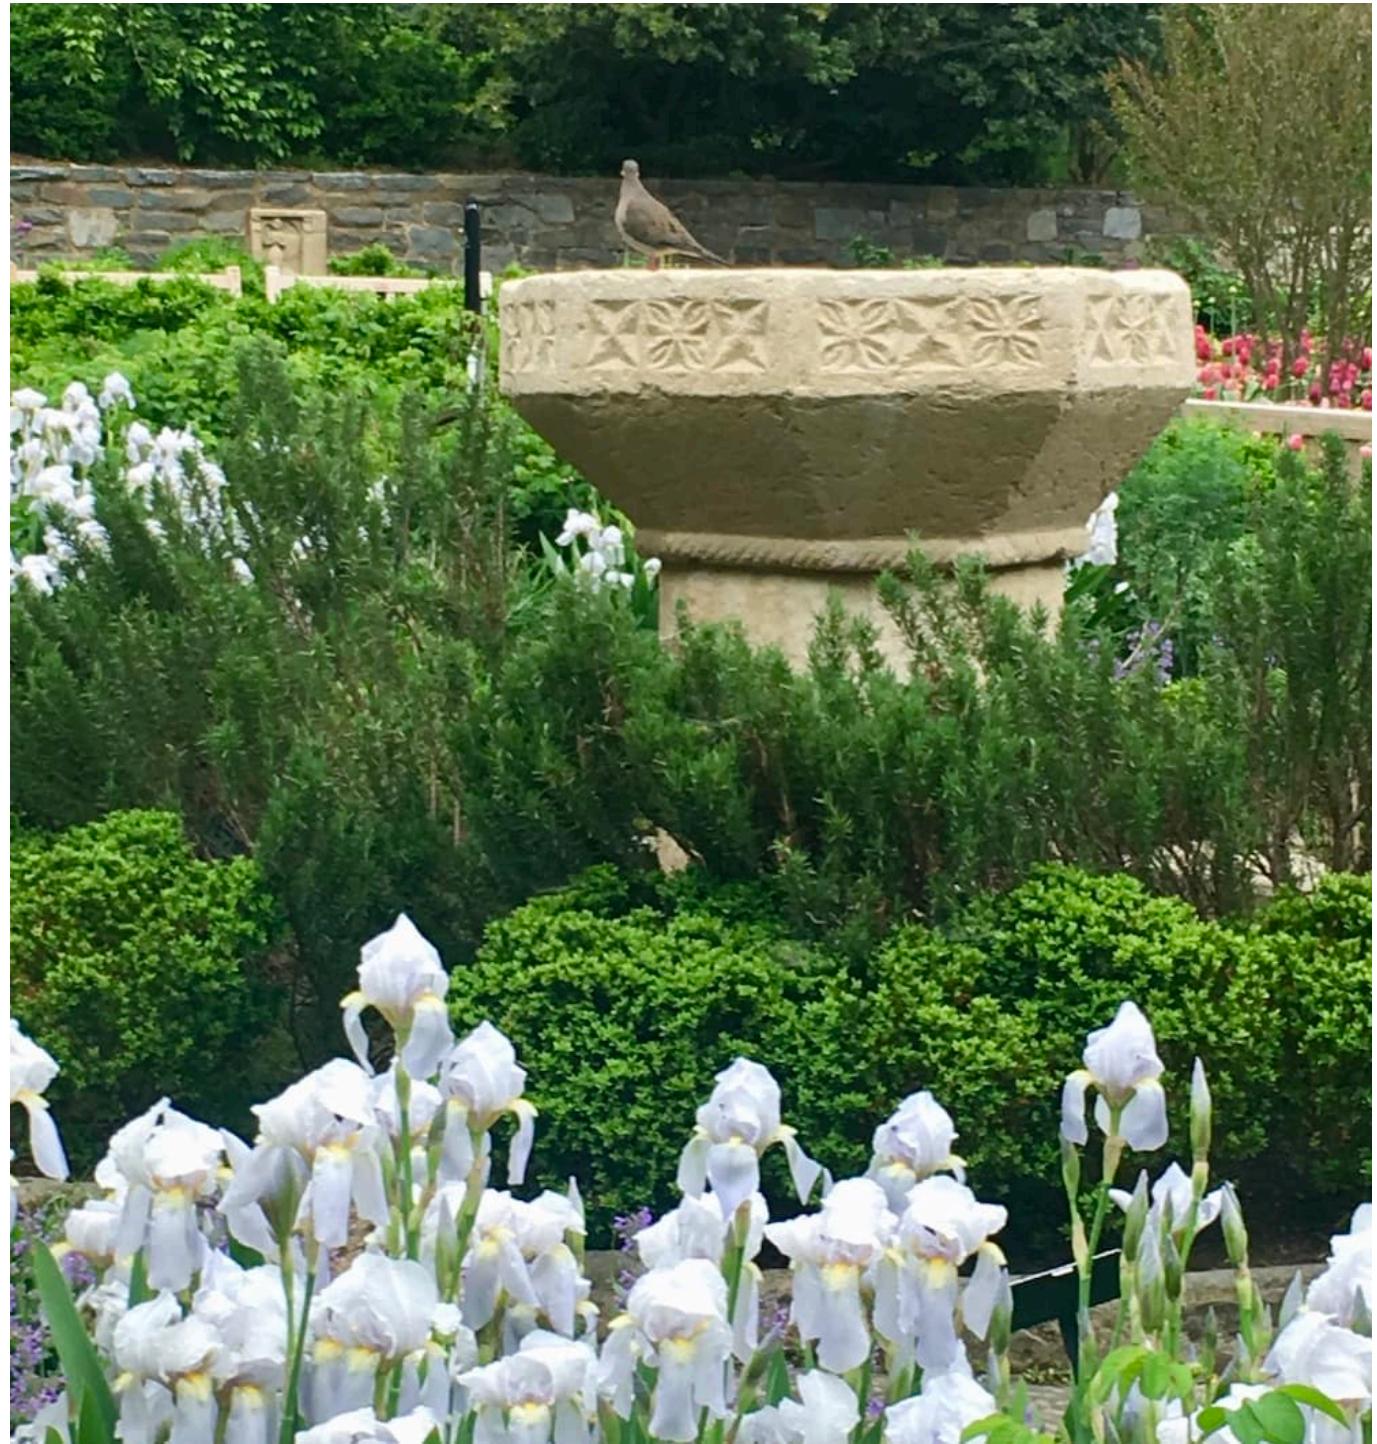
Bas relief behind the Pool of St. Catherine and the Carolingian Font
