### **The Next Phase of Stonework Conservation**

## Stone Conservation in the Bishop's Garden

**The focus of the latest phase of stonework conservation** will be the Bishop's Garden's Norman Court and Norman Arch. All Hallows Guild has engaged McKay Lodge Laboratory, specialists in Fine Art Conservation. They commenced work on Wednesday, September 14, 2022 and it is anticipated to continue through late October under the direction of Marcin Pikus of McKay Lodge.

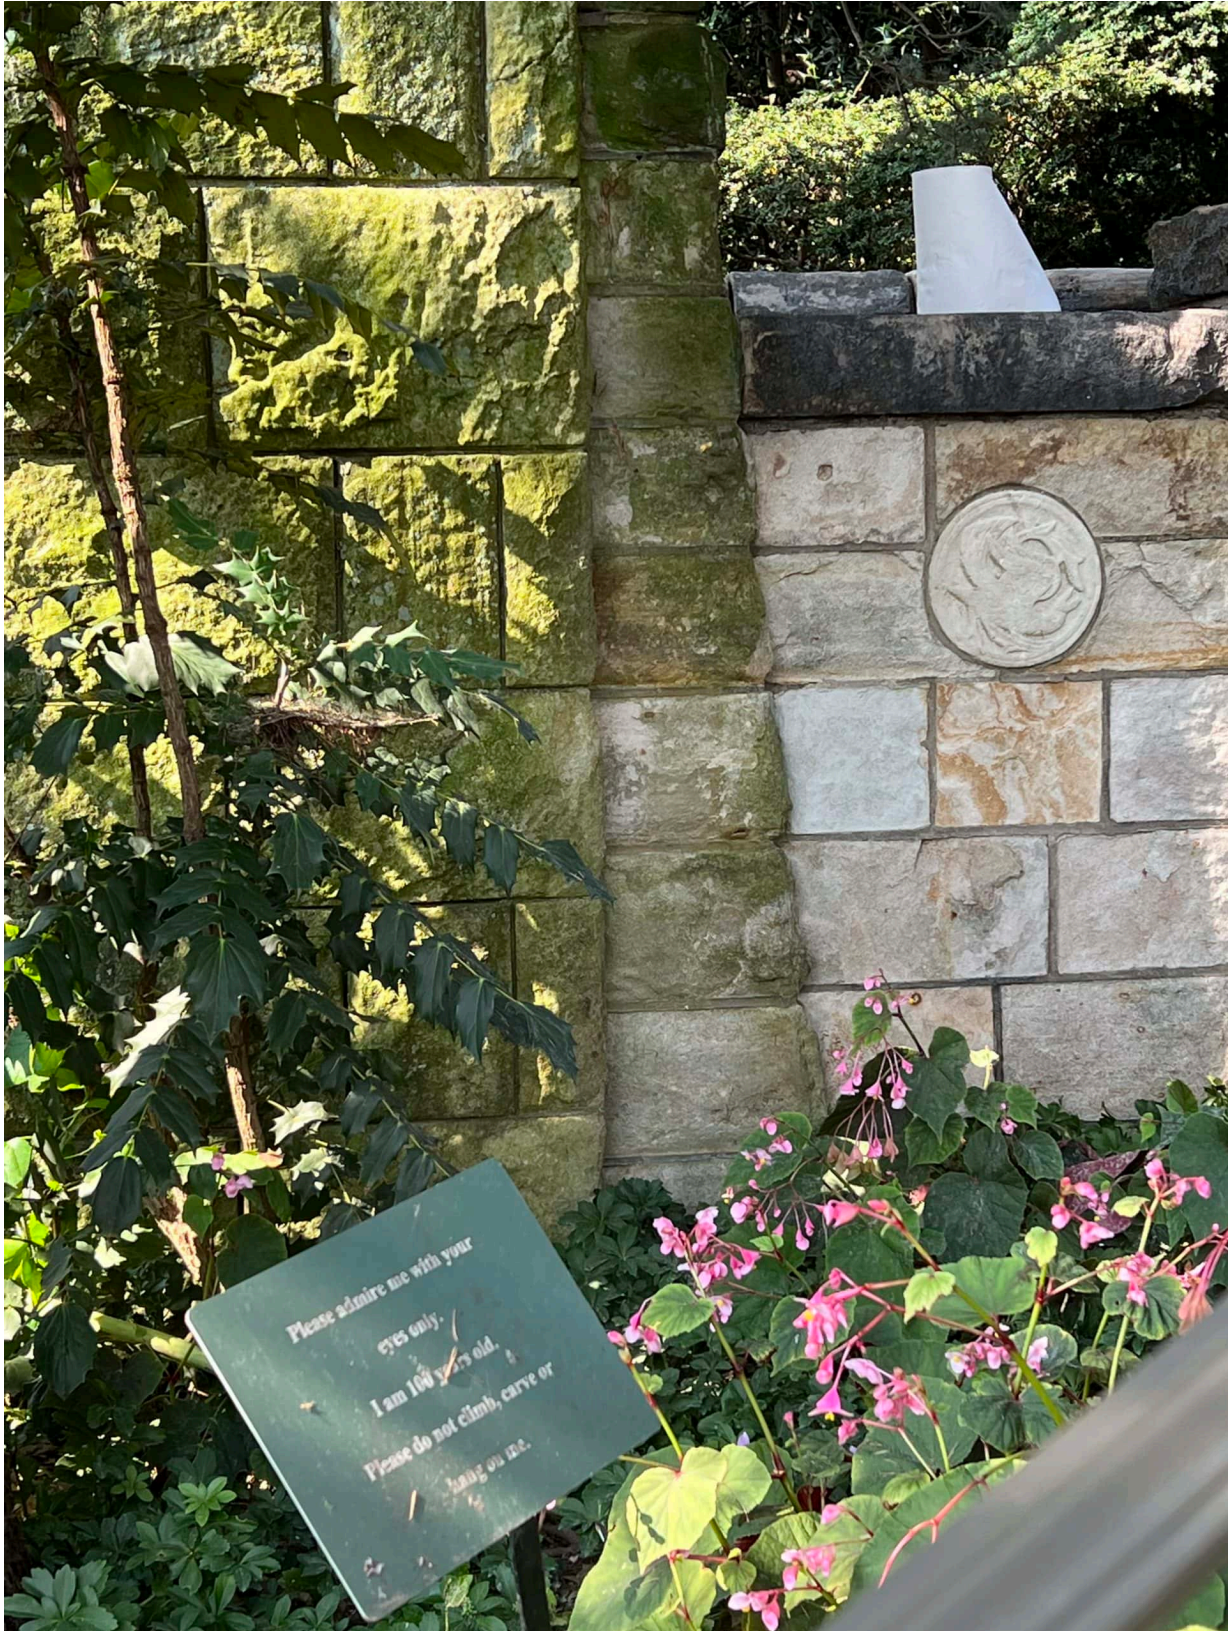
*Conservation and cleaning have the Norman Court temporarily closed*

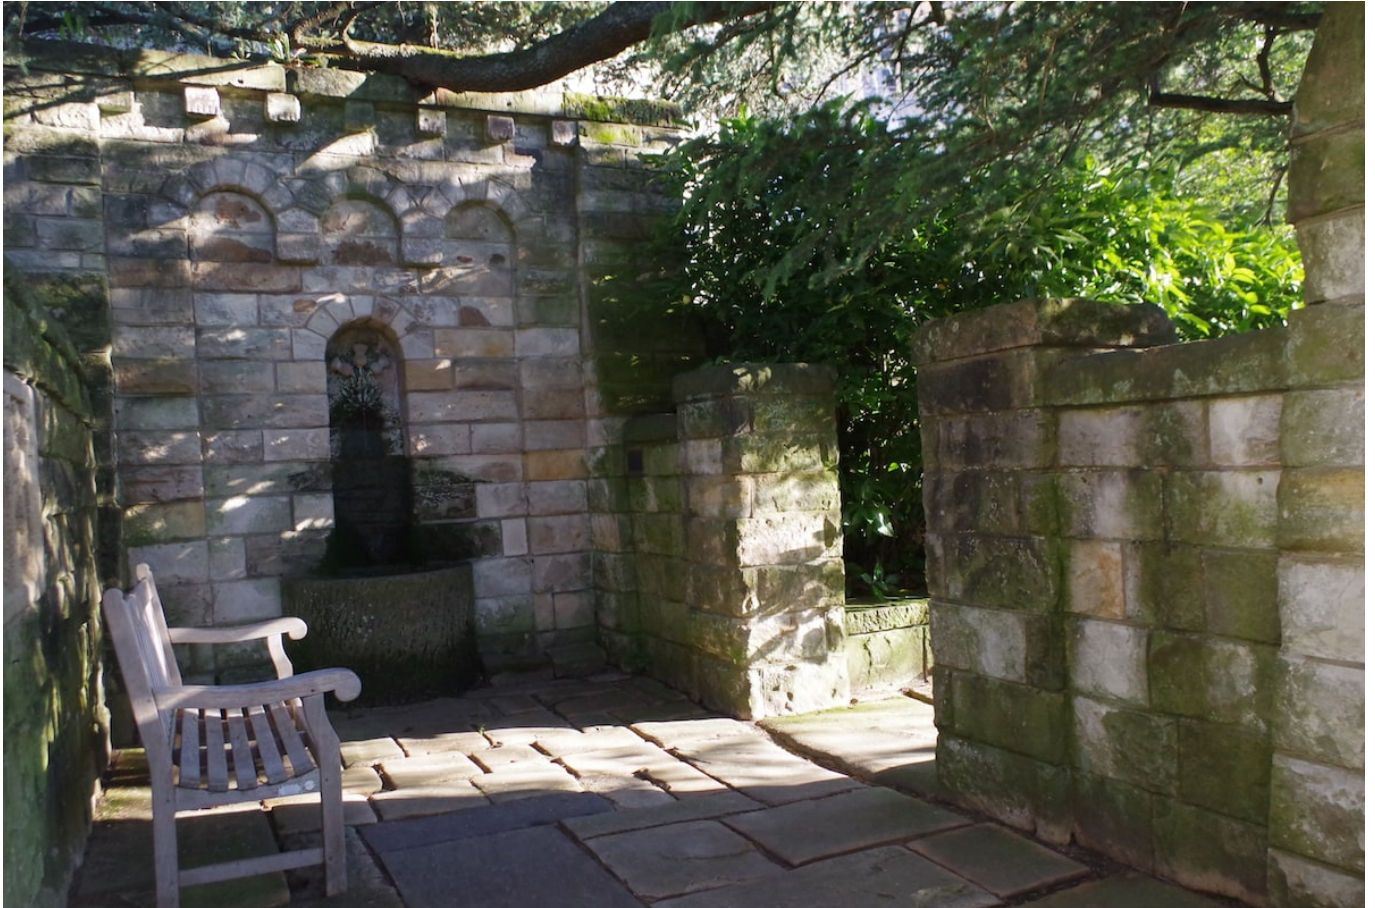
*The Norman Arch and Court prior to conservation work*

**The Norman Court was designed by Florence Bratenahl and completed in 1928.** The Norman arch, from a 12th century ruined monastery in France, is made of Caen limestone. The arch, along with the 15th century bas-relief inside the court, were acquired from the collection of George Grey Barnard, whose collection formed the basis of the Metropolitan Museum of Art's Cloisters in New York City.

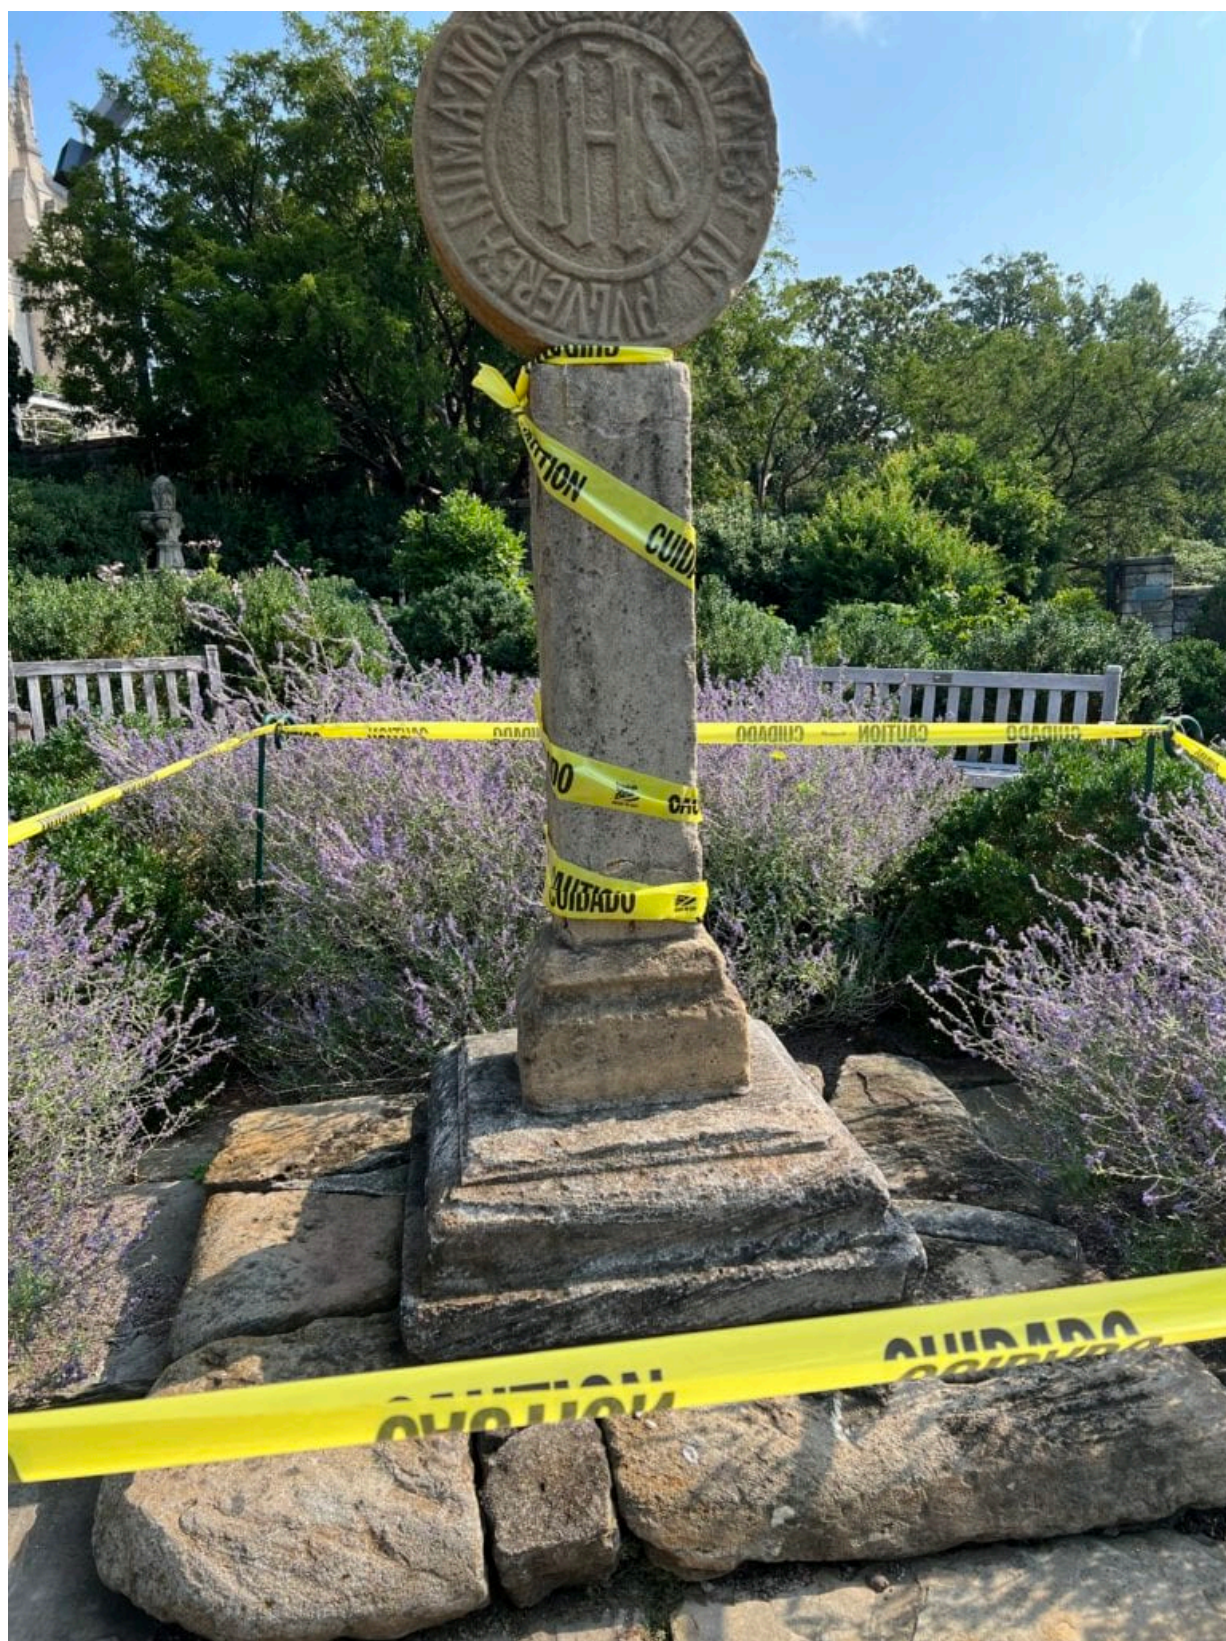
*The Wayside Cross was damaged due to vandalism*

**On Wednesday, September 14, 2022** the Cathedral's Mason Foreman, Joe Alonso and Marcin Pikus of McKay Lodge met to assess damage discovered on the Wayside Cross - which stands near the center of the Bishop's Garden. They determined that the stone cross had suffered from vandalism - with significant cracking near the base. Temporary protection and stabilization has been installed around the cross. It will remain in the garden until later in September when the Cathedral's stonemasons will transport it to their workspace. It is fortunate that we have the expertise of our stonemasons and conservationists at hand and that the damage was discovered before more destruction occurred.

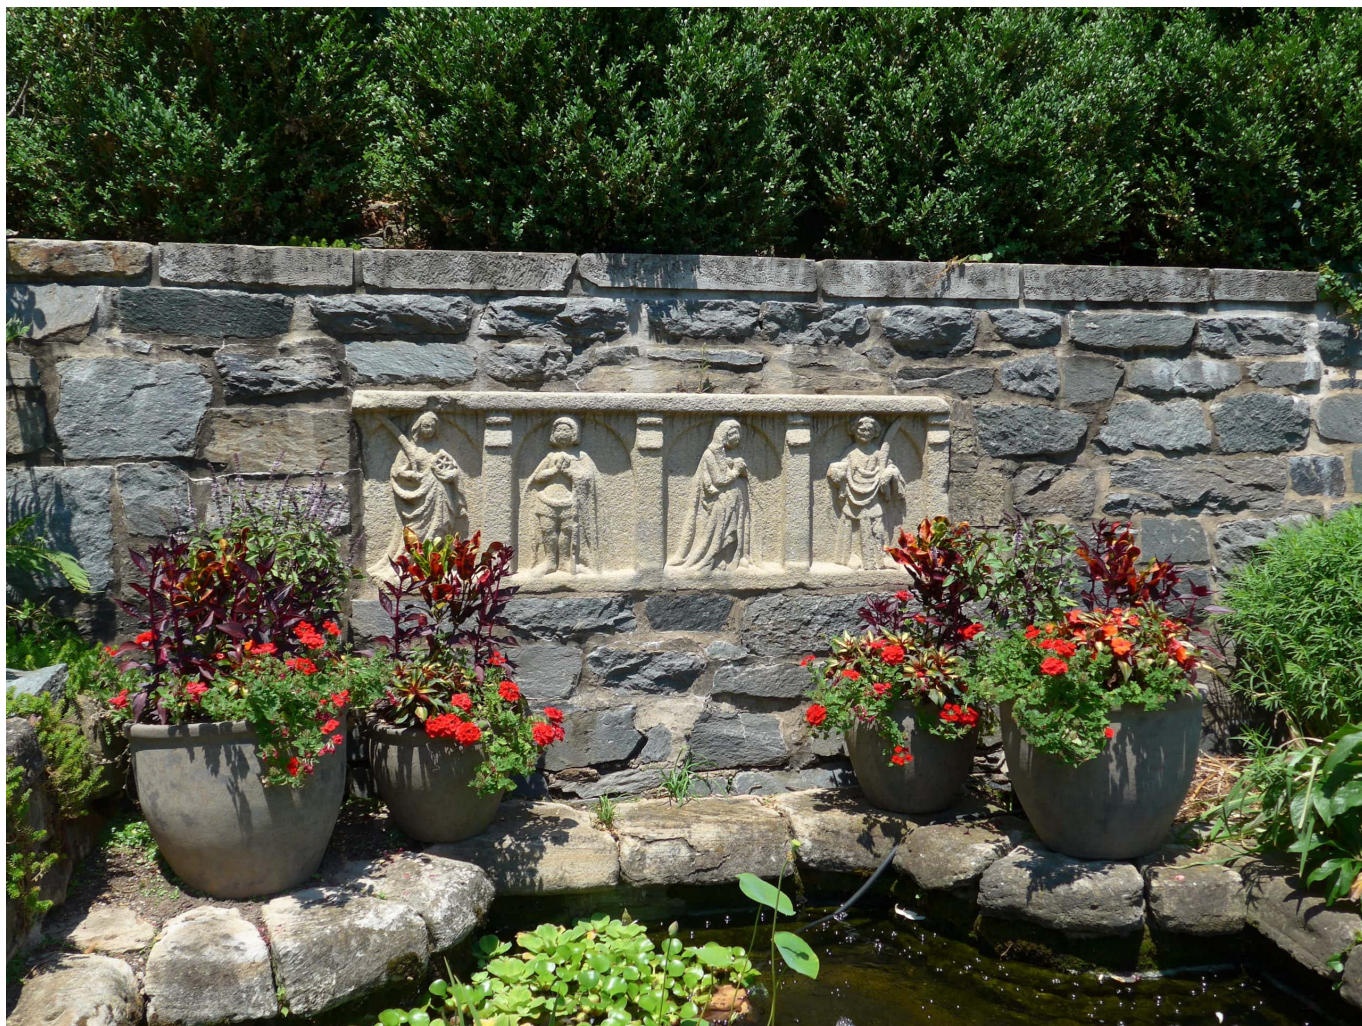
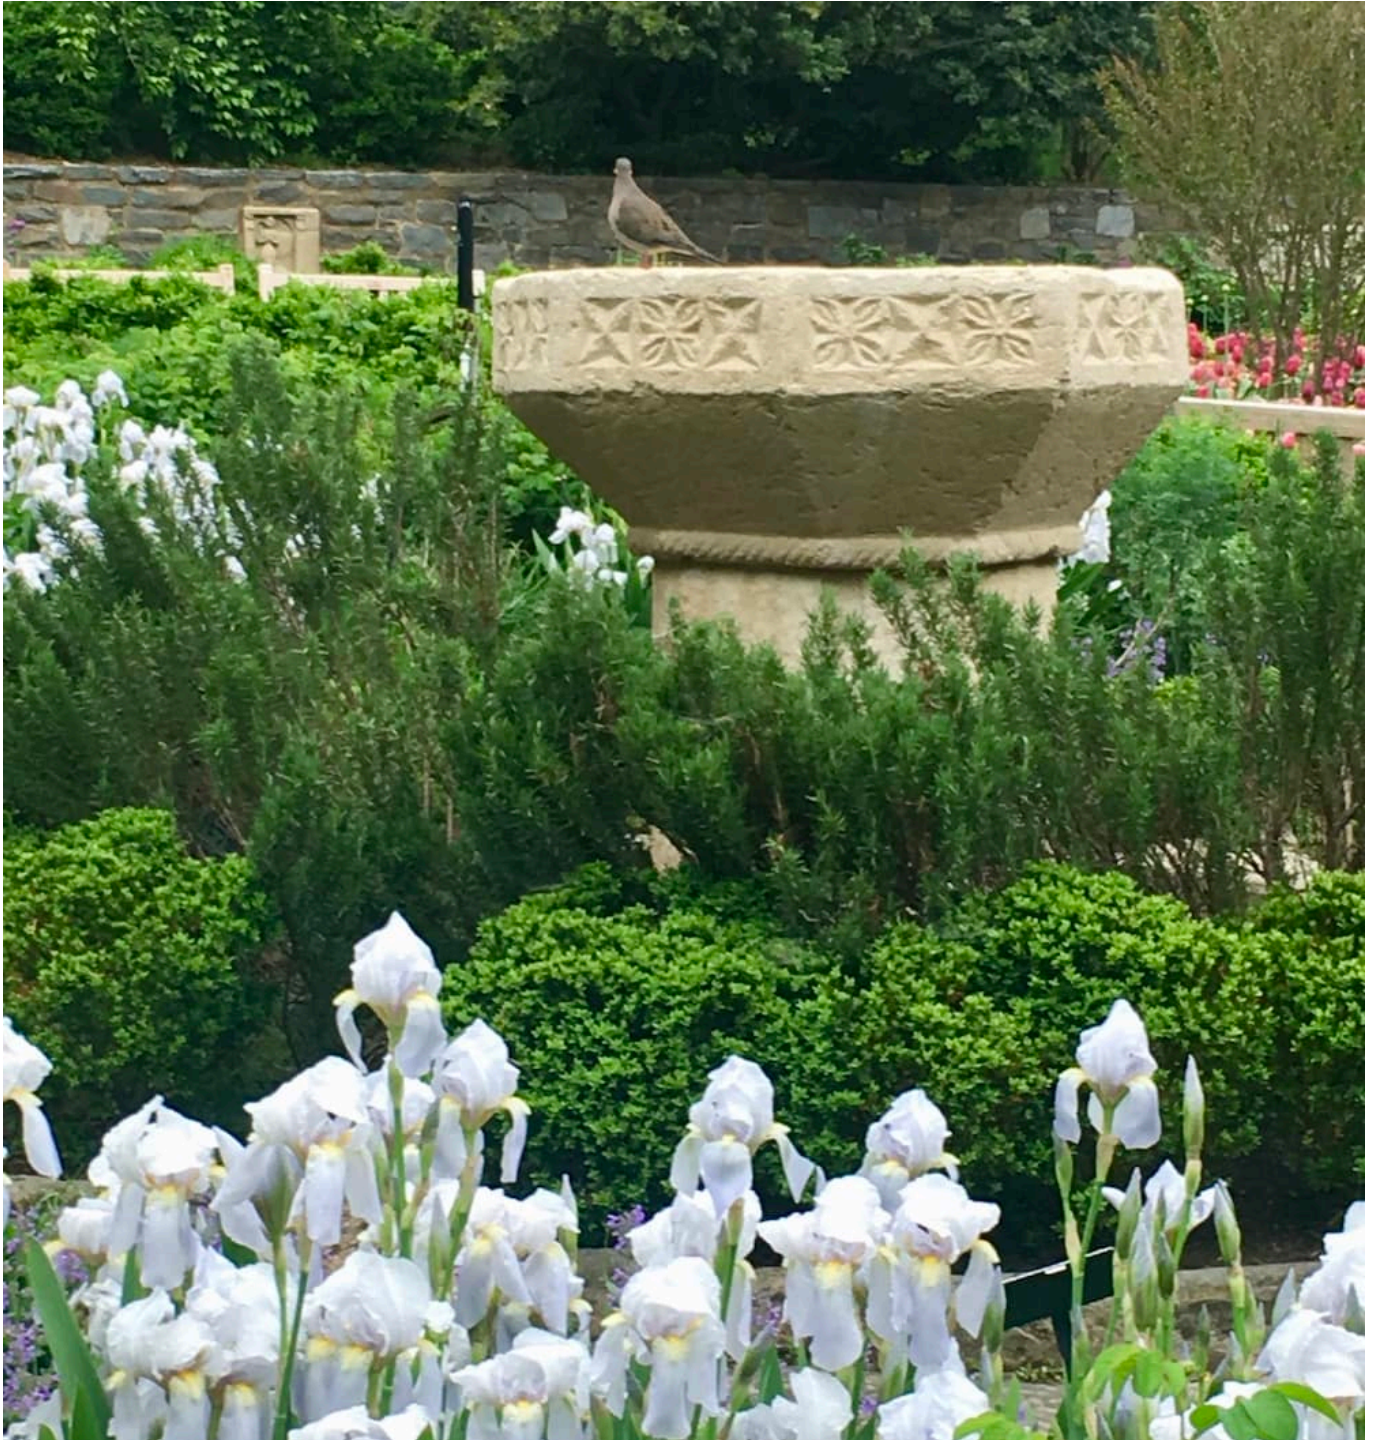
*Bas relief behind the Pool of St. Catherine and the Carolingian Font*

**The conservation work done in October 2018** included five granite bas relief panels and the Carolingian Baptismal Font. McKay Lodge assessed the condition of the reliefs as fair to

poor with degradation of the original surface and the details of the carvings reduced due to water, changing thermal conditions, and microbiological growth. The condition of the Font was also poor with a considerable degree of deterioration. Following the conservation work the artifacts were not only improved in their appearance, but also stabilized and guarded from on-going decay. If you would like to read more about the 2018 stonework restoration [CLICK HERE.](#)
