### **Damage to the Wayside Cross Discovered**

### **Stonemasons to the Rescue**

### **Crafting a New Column Shaft from An Old Piece of Stone**

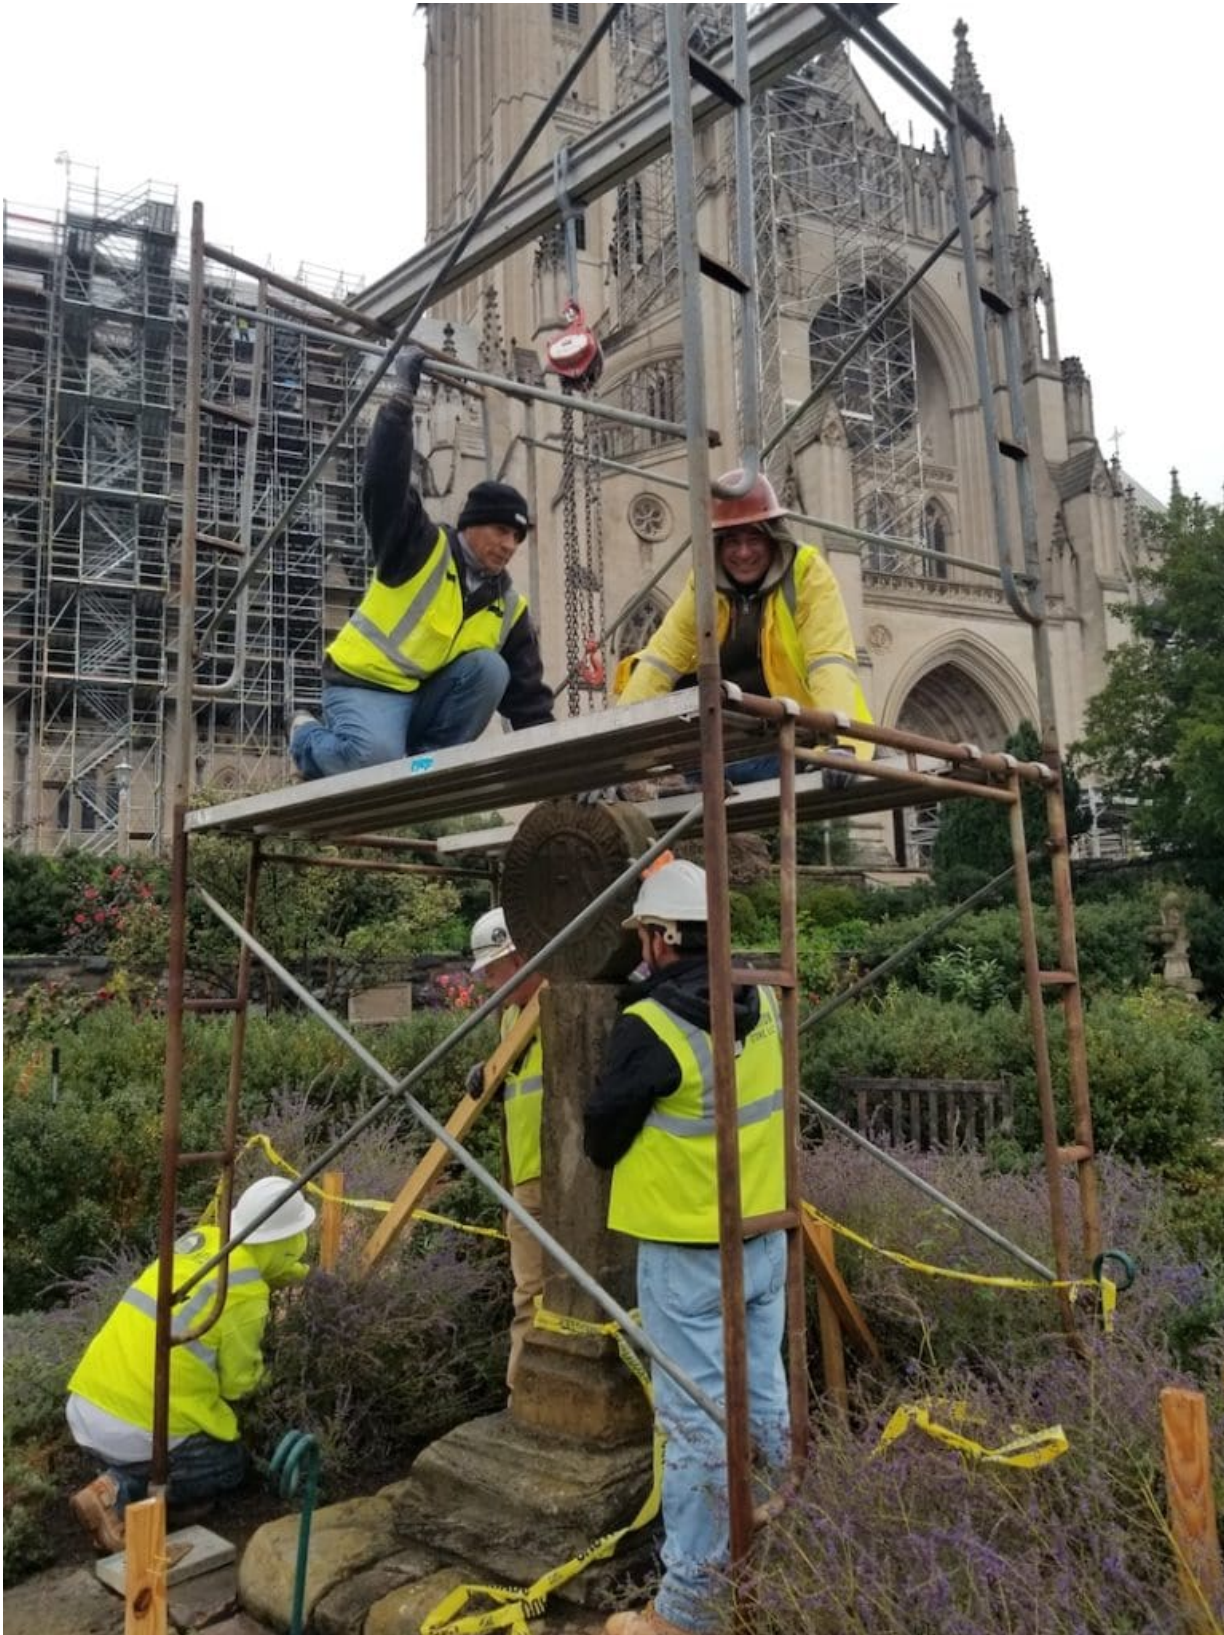
*Stonemasons preparing to remove the damaged Wayside Cross from the Garden*

In our [previous blog post](#) about the stonework conservation in the Bishop's Garden, it was mentioned that the Wayside Cross had sustained damage which was likely the result of vandalism. The base of the cross had a significant crack - which necessitated temporary stabilization.

The cross has now been removed from the Garden for repairs. The Cathedral's stonemasons, along with the stone crew that is working to repair earthquake damage done to the Cathedral in 2011, constructed a lifting scaffold in order to remove the cross from its base. As the cross was lifted, the base crumbled and revealed a rusted steel rod.

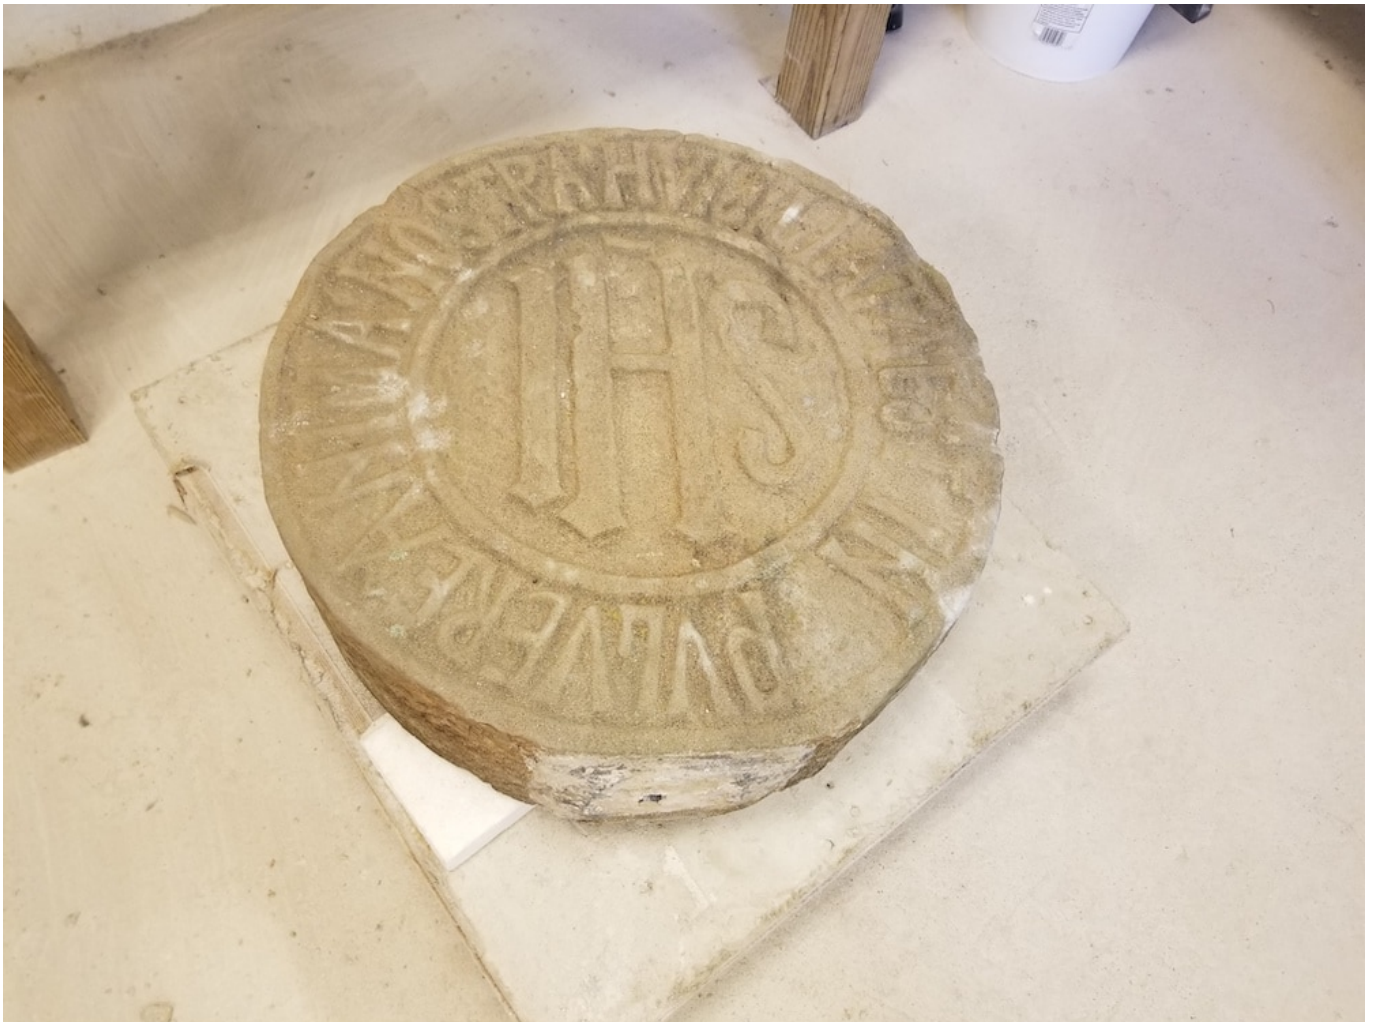
The medallion (the round top of the cross) is the only portion of the Wayside Cross that dates to Medieval times. The vertical shaft (that supports the medallion) was formed of [Aquia Creek Sandstone](#). Aquia stone originated from a quarry about 40 miles south of Washington, D.C., in Stafford County, Va. This type of stone was used in the construction of many of D.C.'s most famous landmarks, including the White House and the U.S. Capitol building. It is also used throughout the Bishop's Garden and is the material that forms the [Pilgrim Steps](#).

*The Medieval Stone Medallion in the Stonemasons' workshop*

the stonemasons located an old Aquia stone stair tread in the Cathedral's facilities building and moved it to their shop - where they were able to create a sound replacement shaft that matches the appearance of the original. The rusted steel rod will be removed from the base and be replaced by a new stainless steel rod, the type being used for the [Cathedral Earthquake repairs](#). The medallion will be anchored to the shaft with the same type of rod.
