### **Damage to the Wayside Cross Discovered**

## **Crafting a New Column Shaft from An Old Piece of Stone**

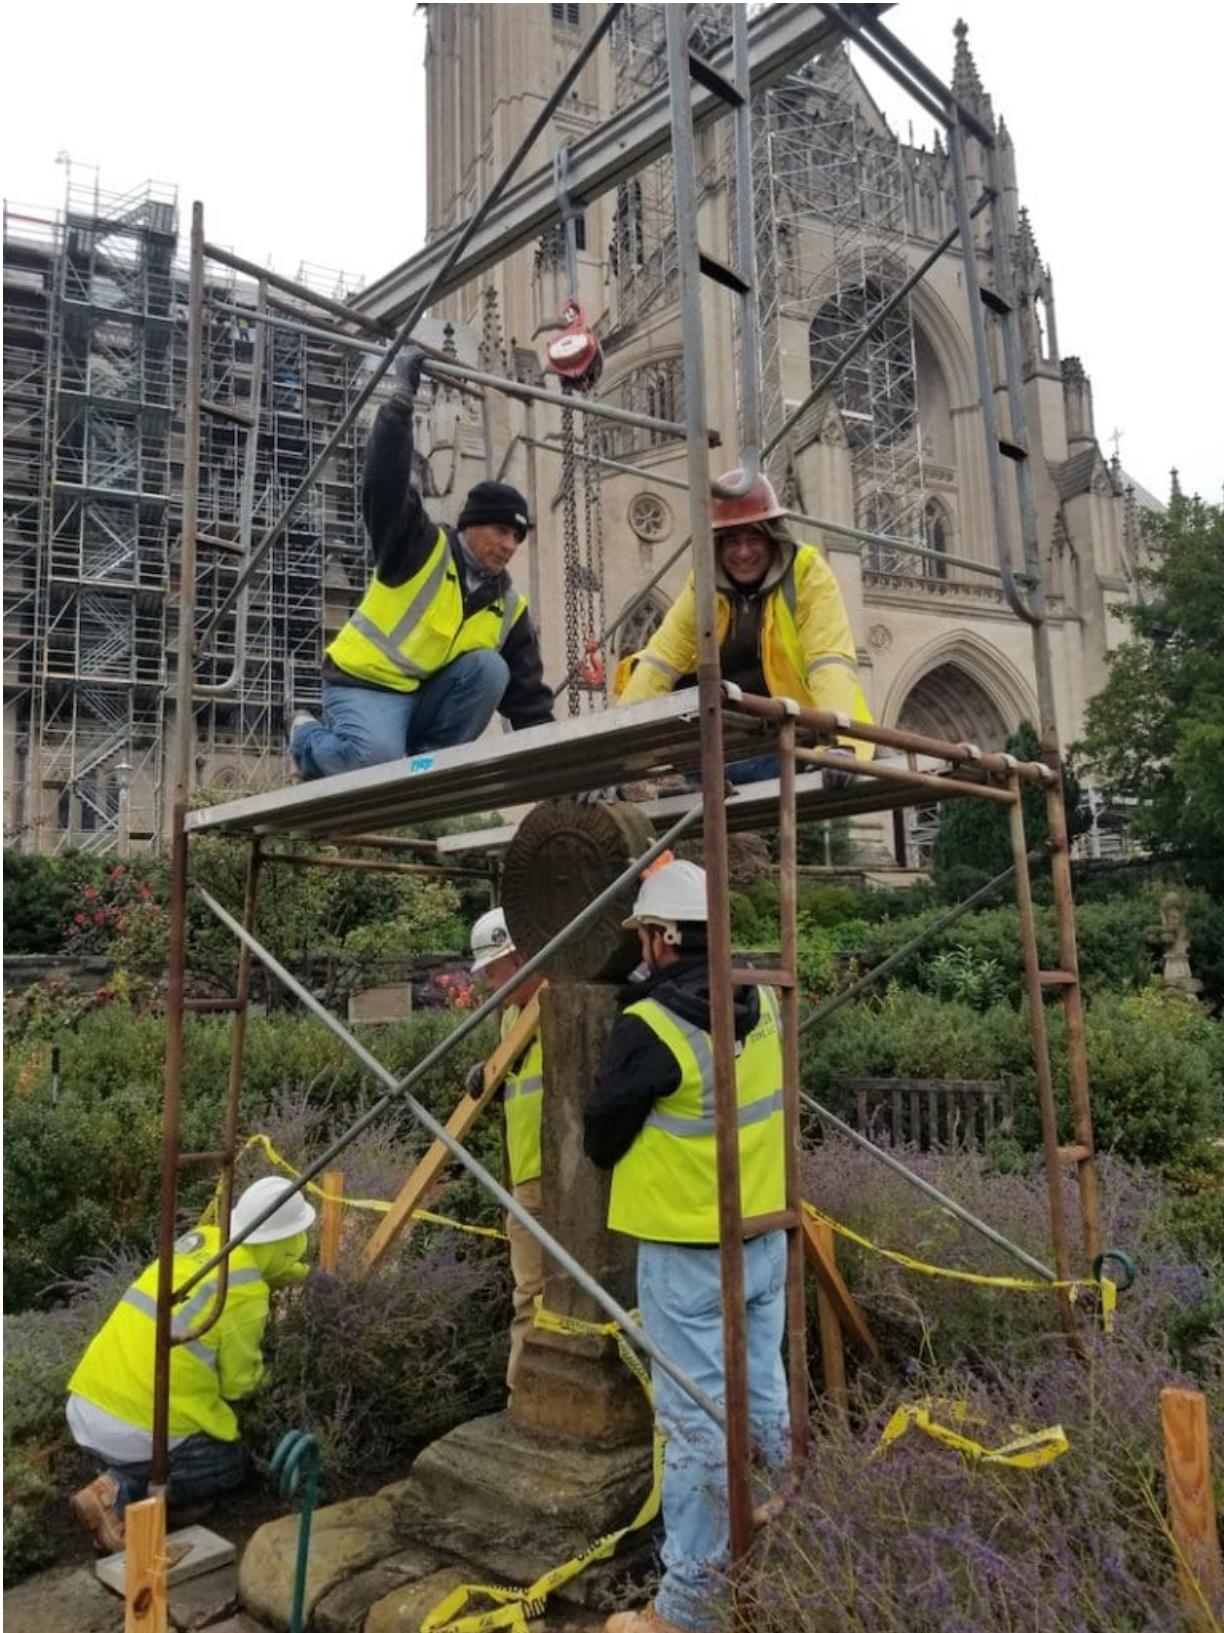
*Stonemasons preparing to remove the damaged Wayside Cross from the Garden*

The cross has now been removed from the Garden for repairs. The Cathedral's stone mason, along with the stone carvers crew that is working to repair earthquake damage done to the Cathedral in 2011, constructed a lifting scaffold in order to remove the cross from its base. As the cross was lifted, the base crumbled and revealed a rusted steel rod.

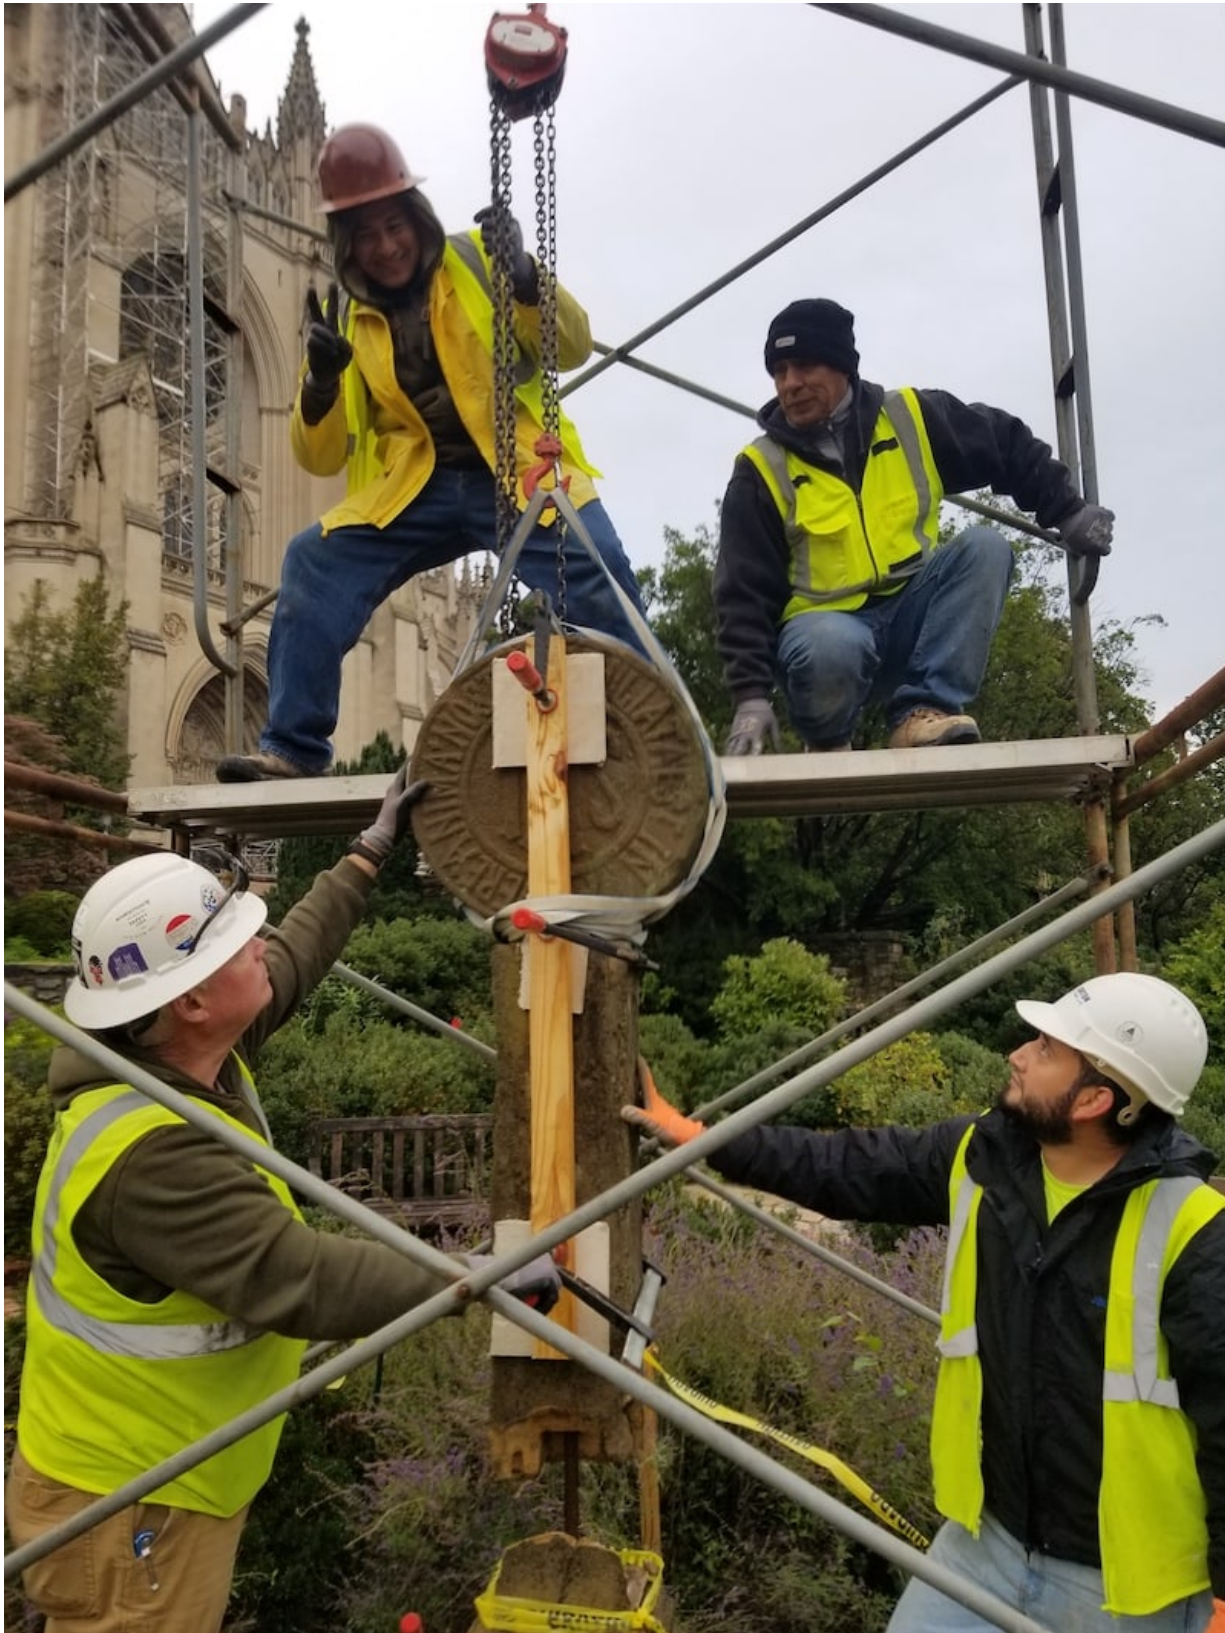
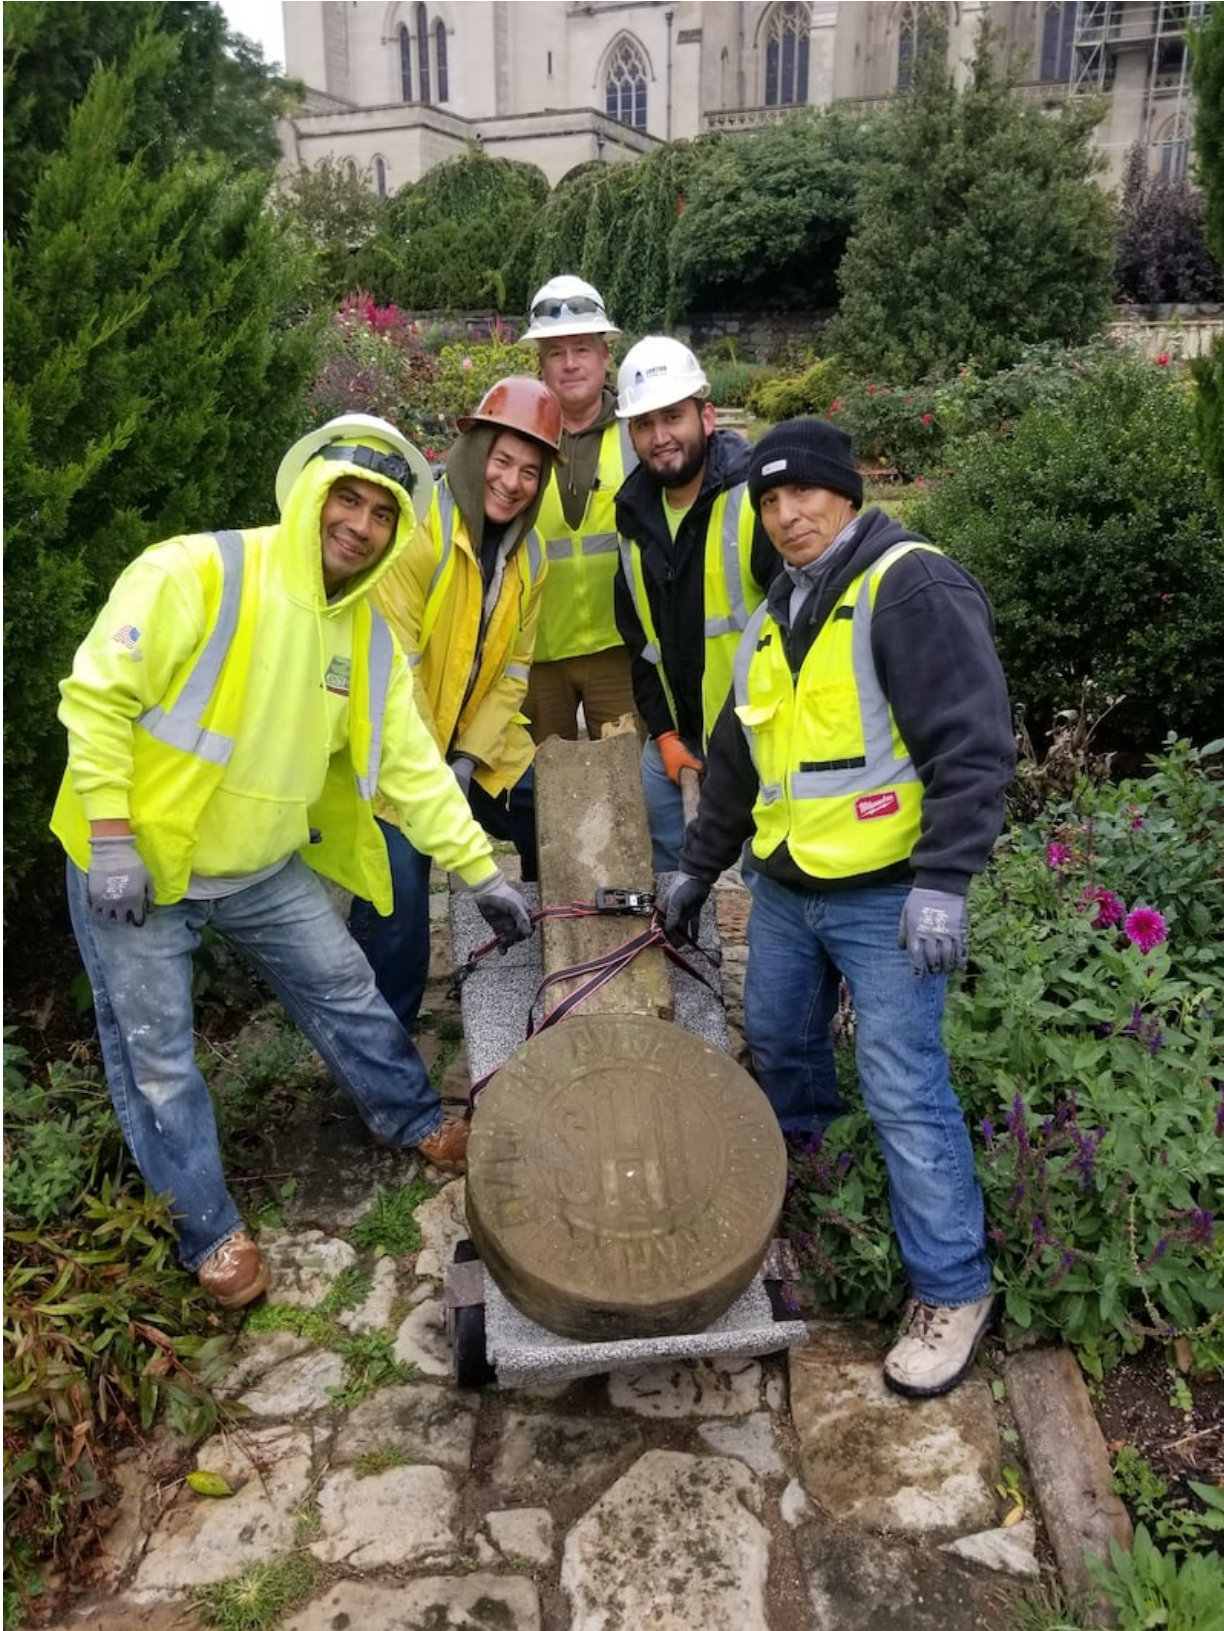
In our [previous blog post](#) about the stonework conservation in the Bishop's Garden, it was mentioned that the Wayside Cross had sustained damage which was likely the result of vandalism. The base of the cross had a significant crack which necessitated temporary stabilization.

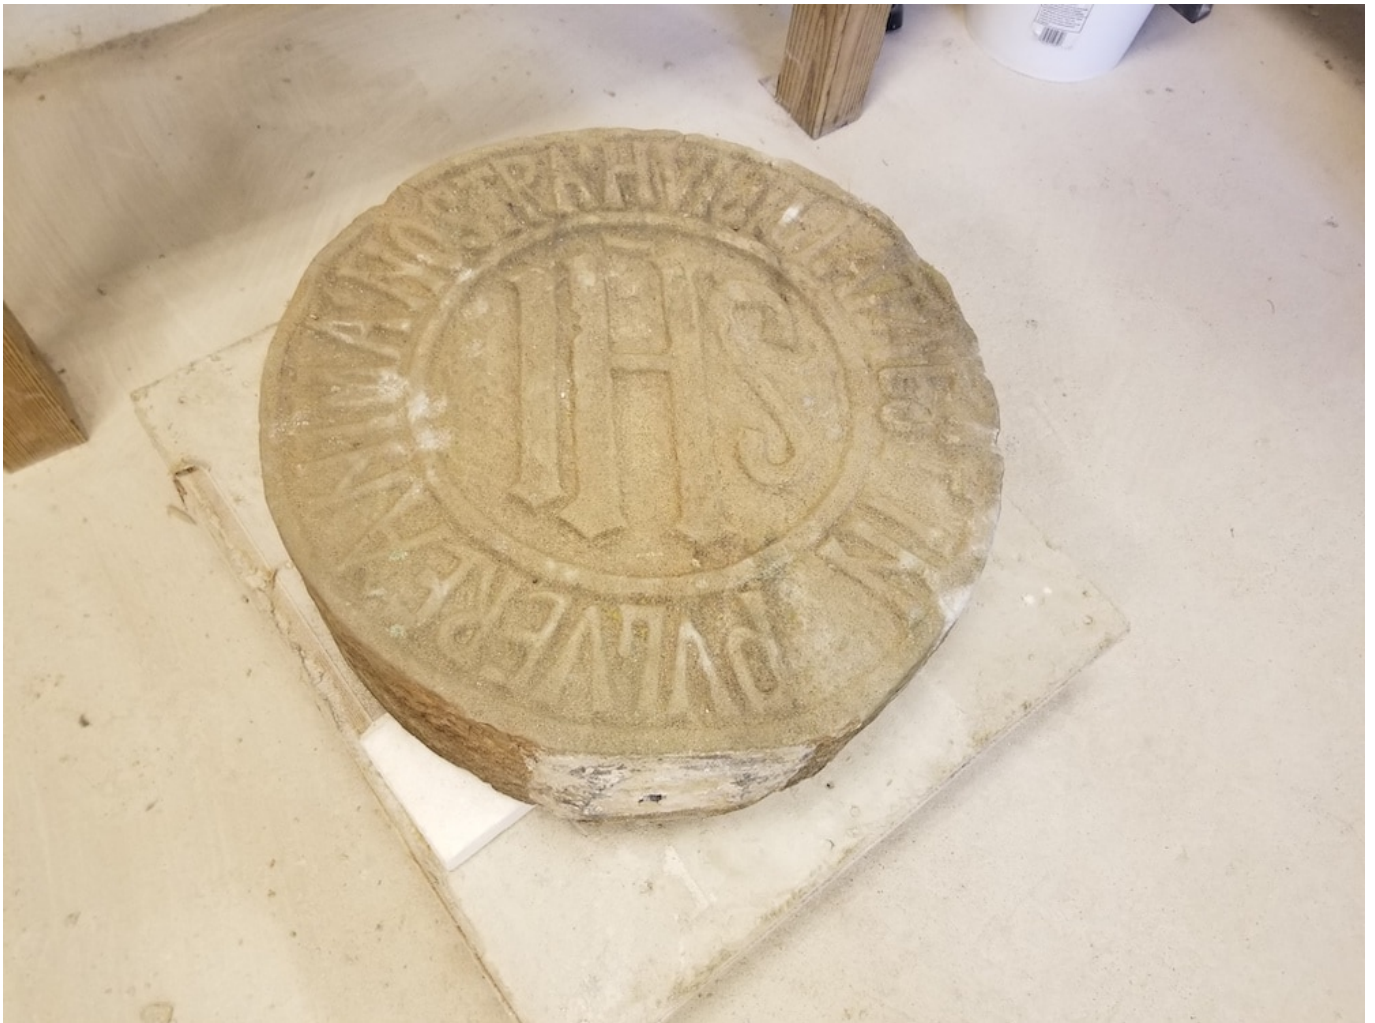
The medallion (the round top of the cross) is the only portion of the Wayside Cross that dates to Medieval times. The vertical shaft (that supports the medallion) was formed of [Aquia Creek Sandstone](#). Aquia stone originated from a quarry about 40 miles south of Washington, D.C., in Stafford County, Va. This type of stone was used in the construction of many of D.C.'s most famous landmarks, including the White House and the U.S. Capitol building. It is also used throughout the Bishop's Garden and is the material that forms the [Pilgrim Steps](#).

*The medieval Stone Medallion in the stone masons' workshop*

The three-foot-tall stone shaft is cracked at both ends and cannot be salvaged. Fortunately, the stone mason located an old Aquia stone stair tread in the Cathedral's facilities building and moved it to the shop where they were able to create a sound replacement shaft that matches the appearance of the original. The rusted steel rod will be removed from the base and be replaced by a new stainless steel rod, the type being used for the [Cathedral earthquake repairs](#). The medallion will be anchored to the shaft with the same type of rod.
