### **Damage to the Wayside Cross Discovered**

## Wayside Cross Update

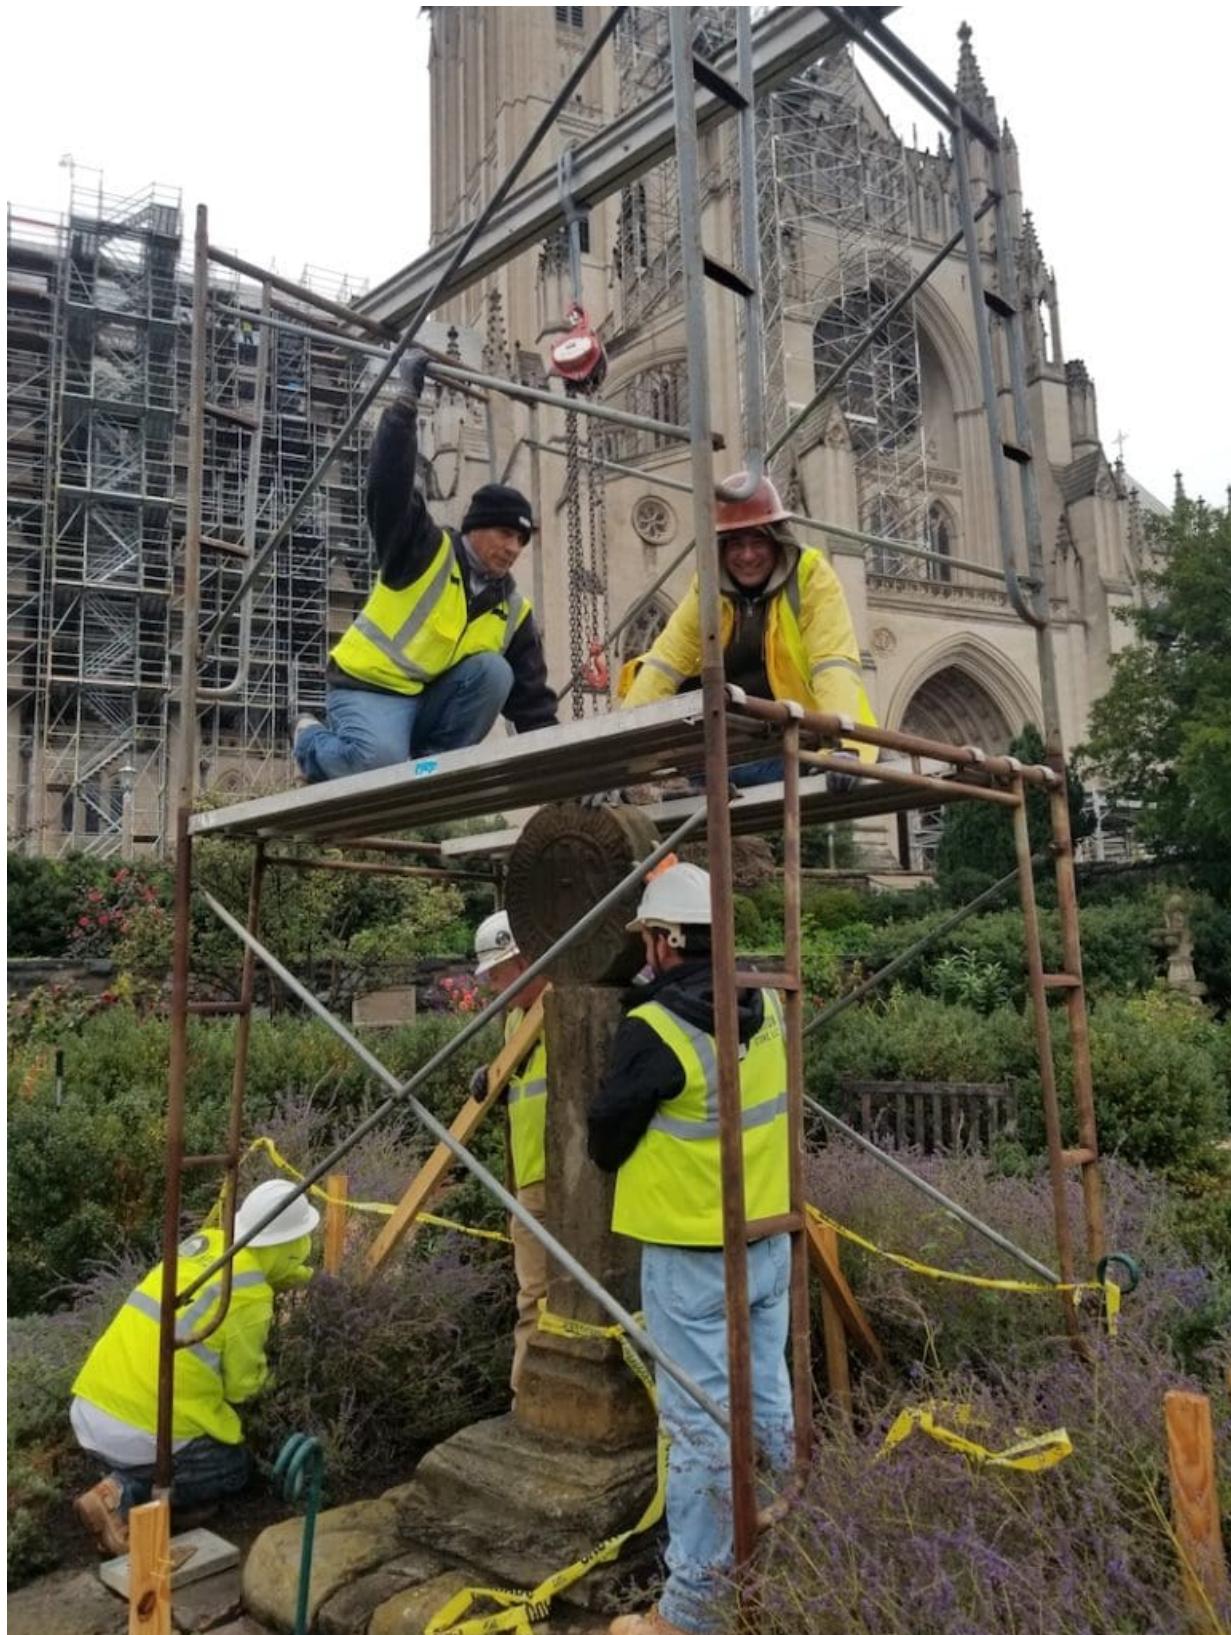
*Stonemasons preparing to remove the damaged Wayside Cross from the Garden*

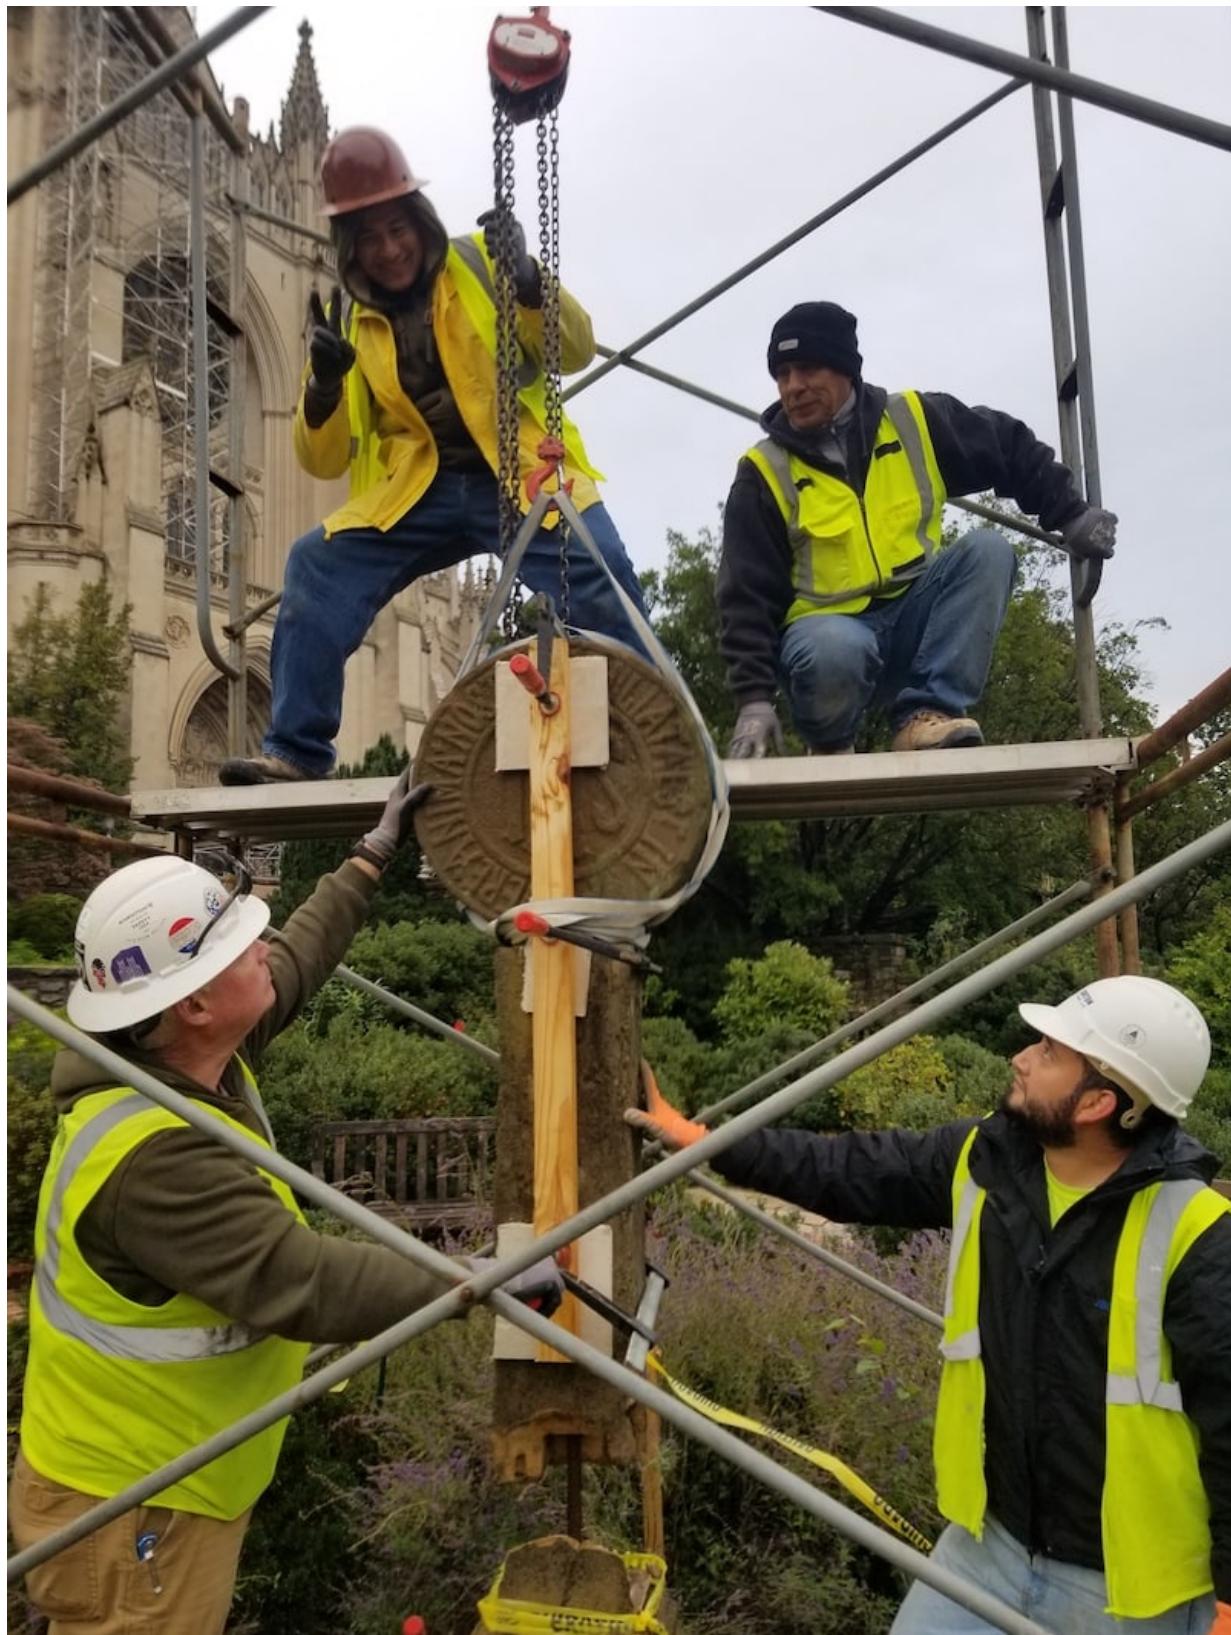
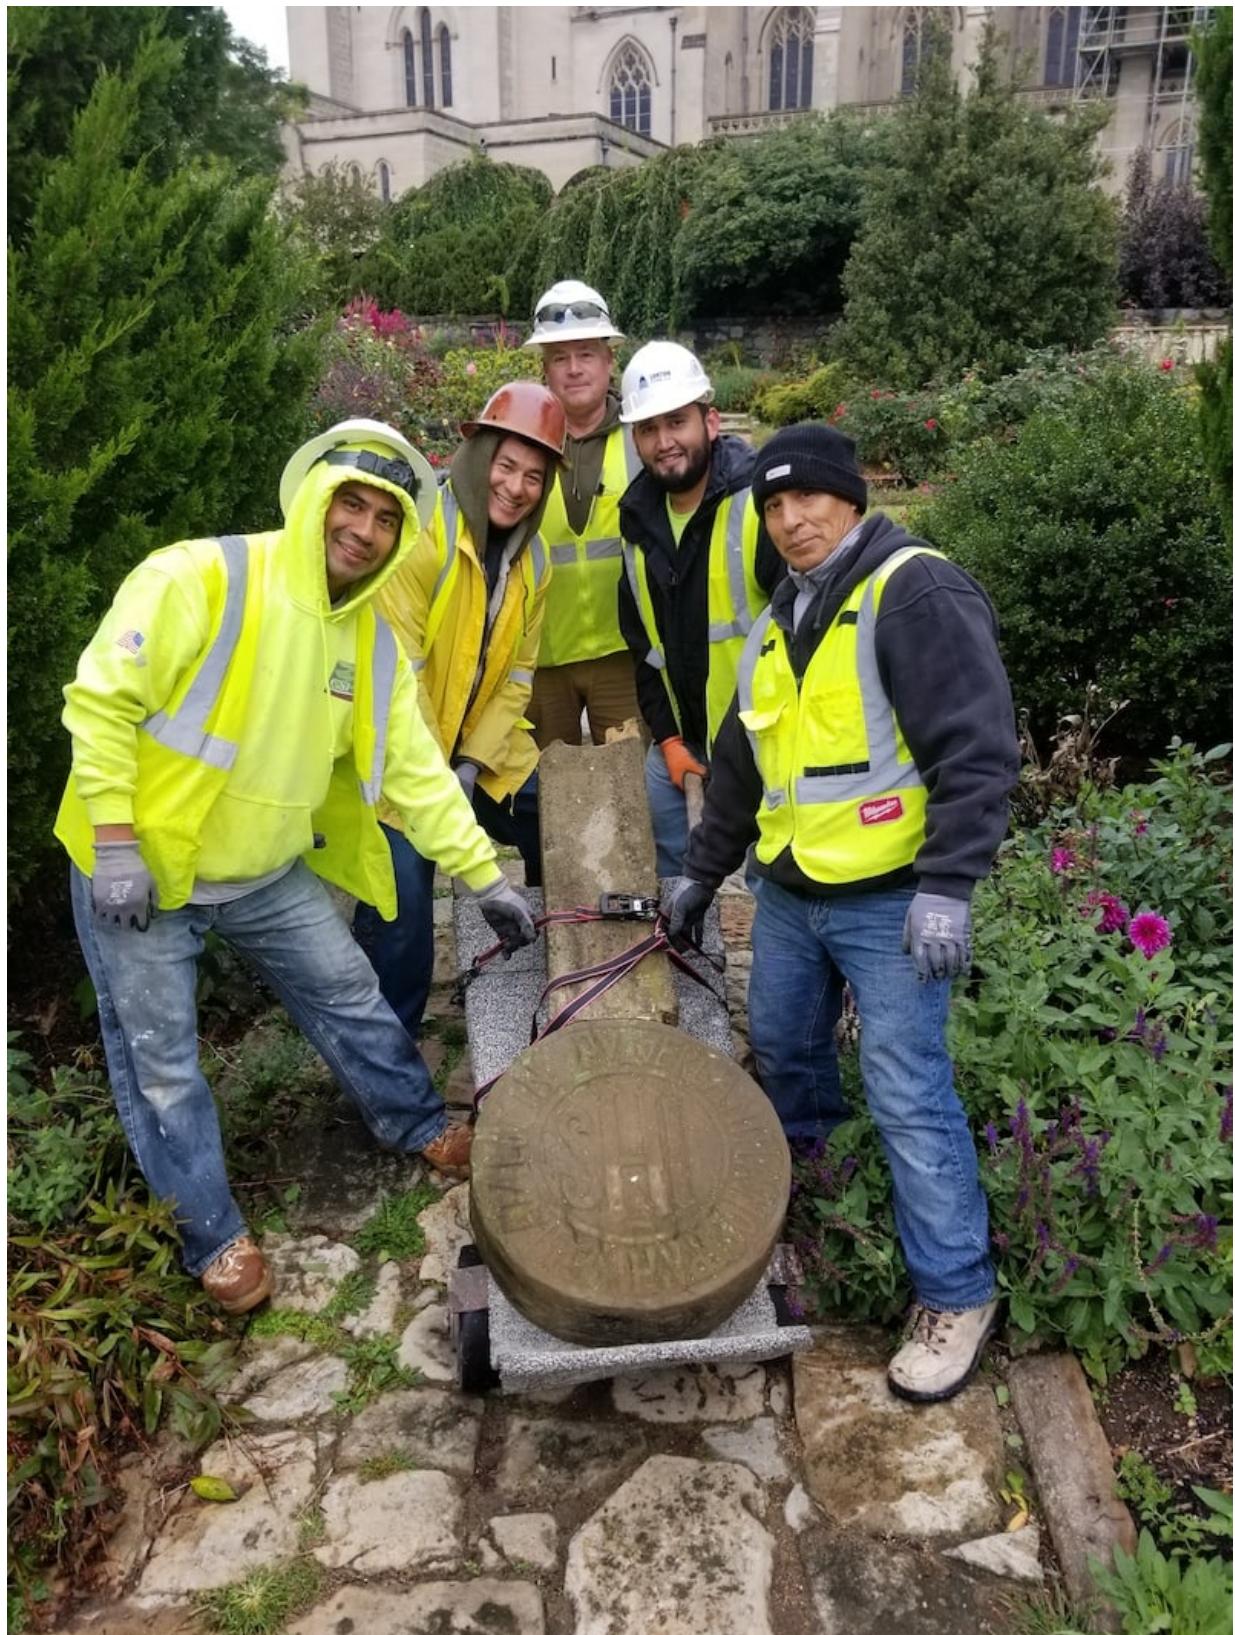
In our [\*\*previous blog post\*\*](#) about the stonework conservation in the Bishop's Garden, it was mentioned that the Wayside Cross had sustained damage which was likely the result of vandalism. The base of the cross had a significant crack which necessitated temporary stabilization.

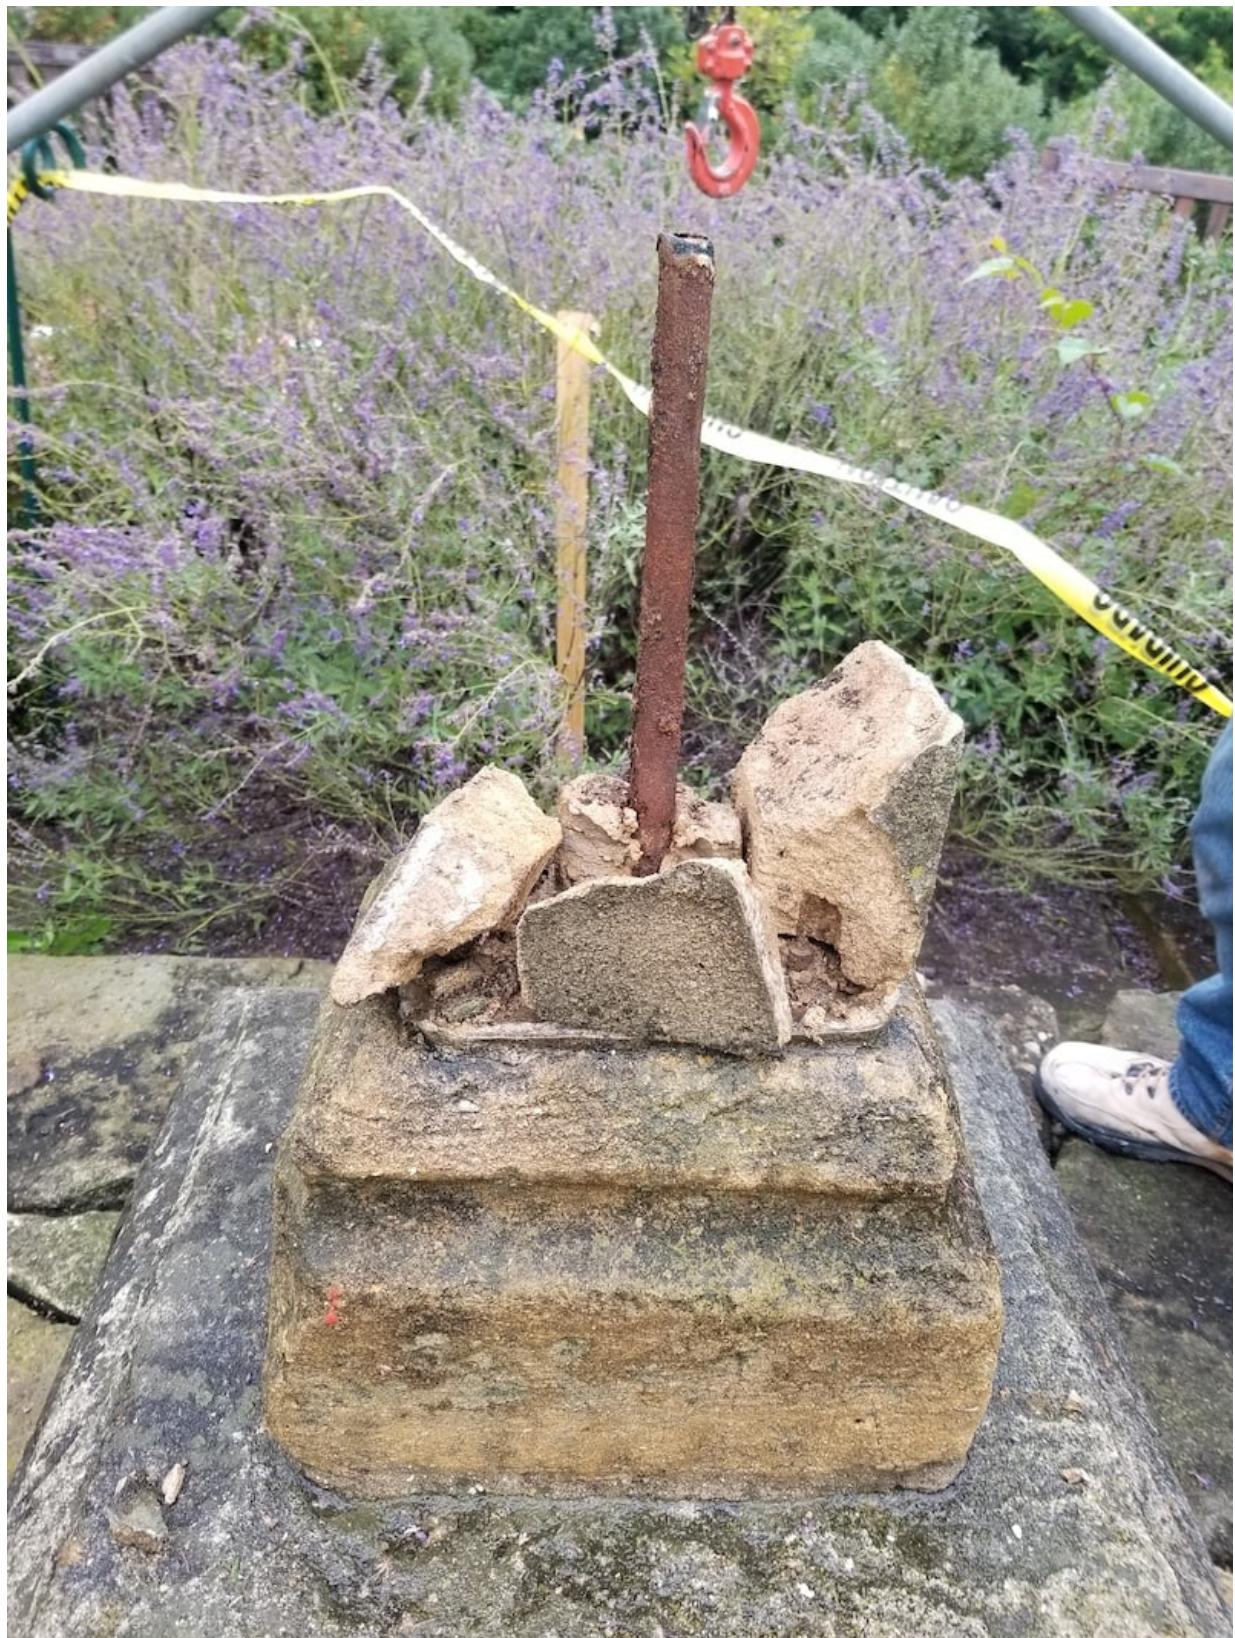
The cross has now been removed from the Garden for repairs. The Cathedral's stone mason, along with the stone carvers crew that is working to repair earthquake damage done to the Cathedral in 2011, constructed a lifting scaffold in order to remove the cross from its base. As the cross was lifted, the base crumbled and revealed a rusted steel rod.

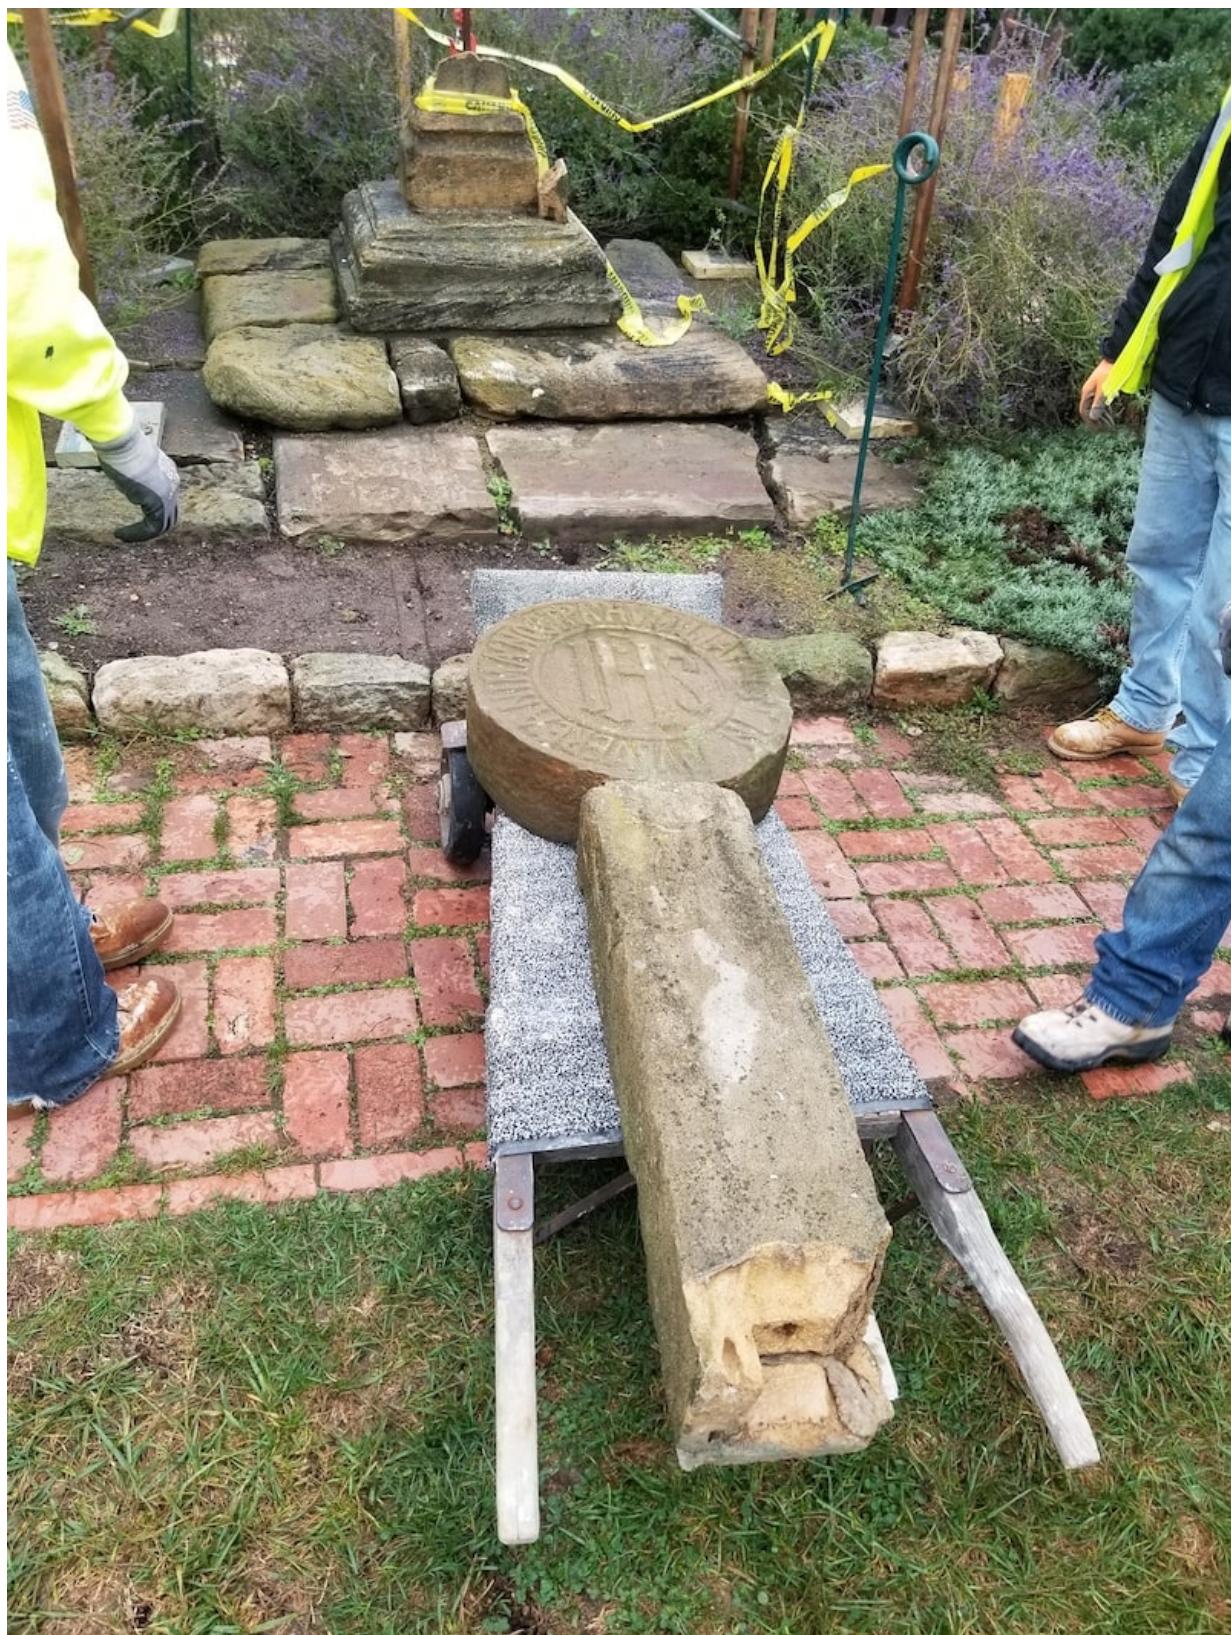
The medallion (the round top of the cross) is the only portion of the Wayside Cross that dates to Medieval times. The vertical shaft (that supports the medallion) was formed of [Aquia Creek Sandstone](#). Aquia stone originated from a quarry about 40 miles south of Washington, D.C., in Stafford County, Va. This type of stone was used in the construction of many of D.C.'s most famous landmarks, including the White House and the U.S. Capitol building. It is also used throughout the Bishop's Garden and is the material that forms the [Pilgrim Steps](#).

The three-foot-tall stone shaft is cracked at both ends and cannot be salvaged. Fortunately, the stone mason located an old Aquia stone stair tread in the Cathedral's facilities building and moved it to the shop where they were able to create a sound replacement shaft that matches the appearance of the original. The rusted steel rod will be removed from the base and be replaced by a new stainless steel rod, the type being used for the [\*\*Cathedral earthquake repairs\*\*](#). The medallion will be anchored to the shaft with the same type of rod.

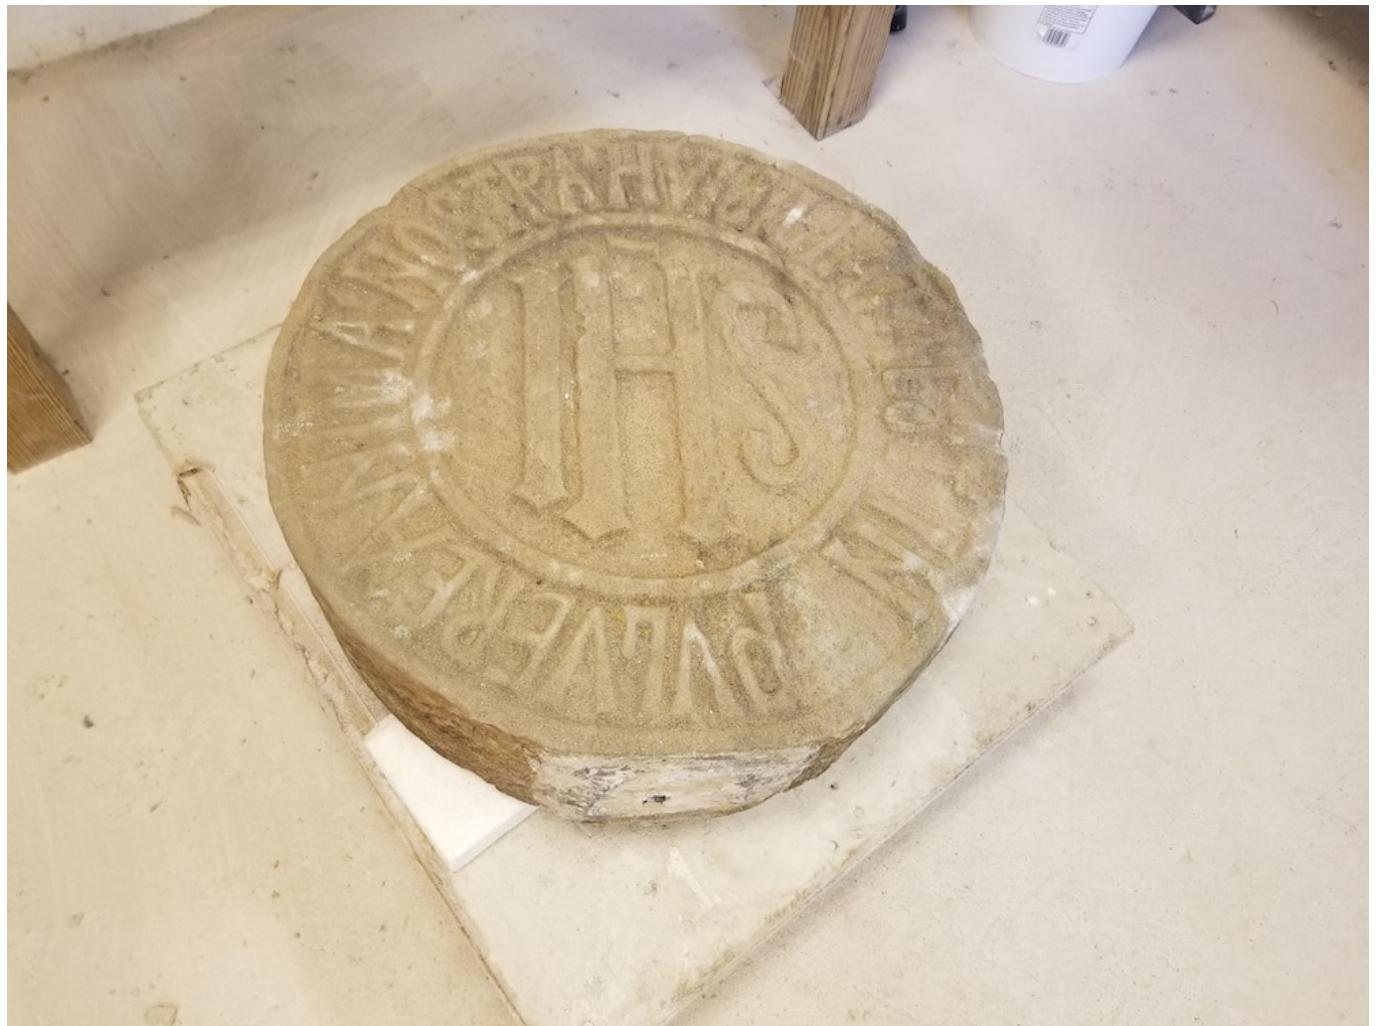
*The medieval Stone Medallion in the stone masons' workshop*

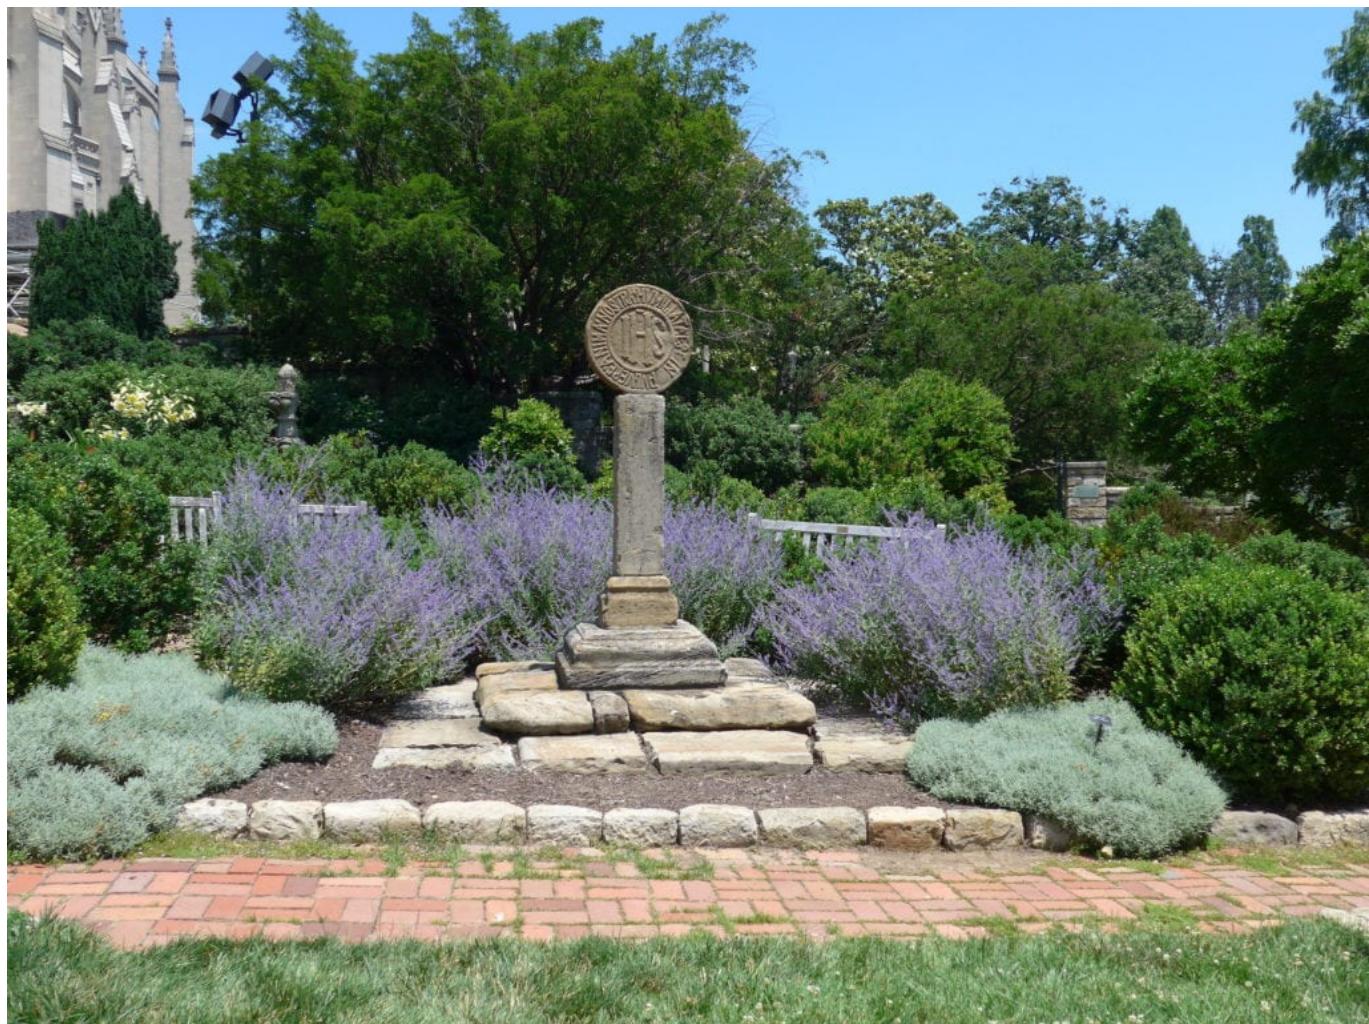
*The Wayside Cross in the Garden prior to damage*
