**December 30, 2018**

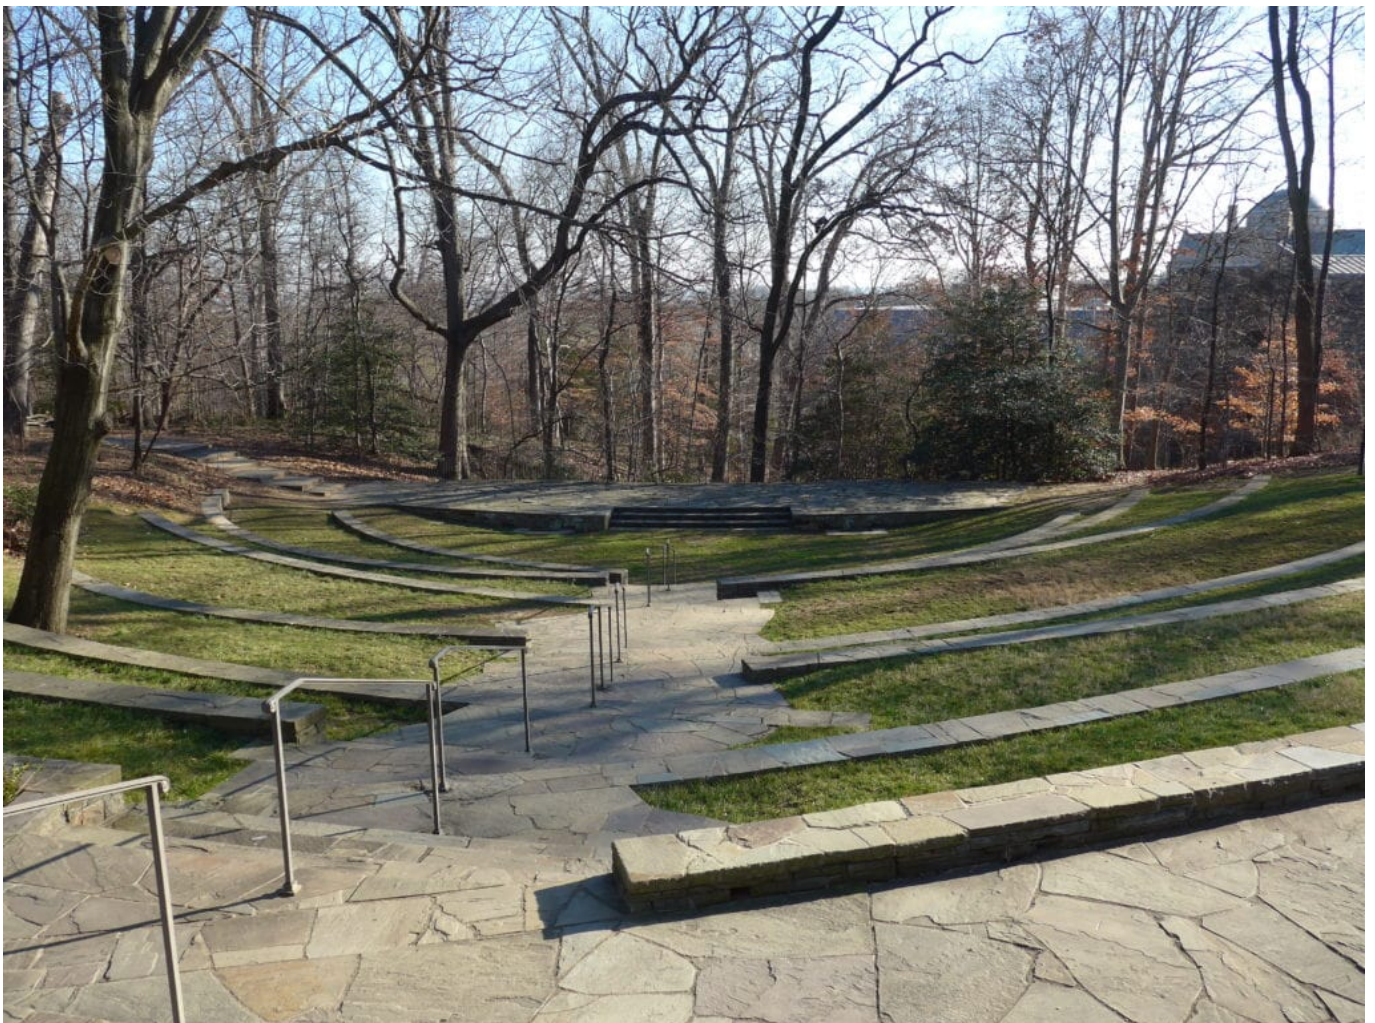
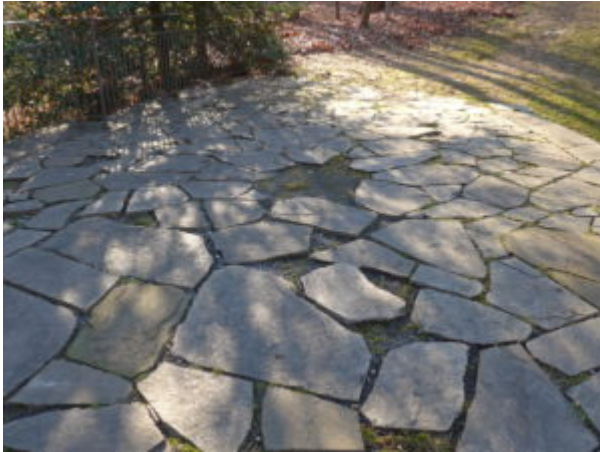
The record-breaking rainfall of 2018 may have lowered water bills and minimized use of irrigation, but all that water took its toll on our landscape nonetheless. Increased runoff has affected the Olmsted Woods and at times overwhelmed the water-control measures we installed some years ago. We are addressing this with engineers and architects.

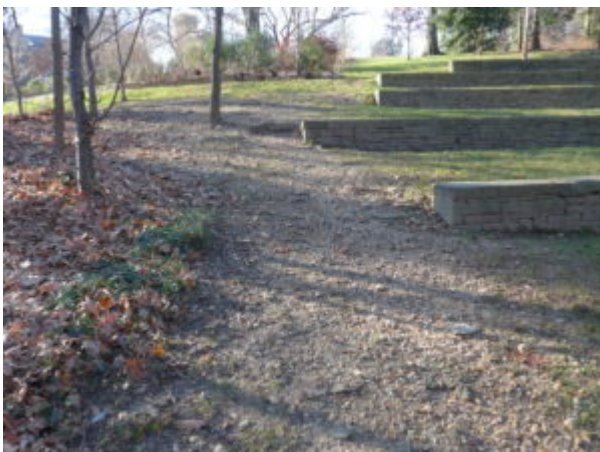
The All Hallows Amphitheater, completed in 2008, also is under pressure from rains and runoff. The floor of the stage, or altar, pre-existed the building of the Amphitheater. The stone paving was not set in concrete, and although ten years ago, at the time of construction, it was deemed sound, it has deteriorated in the interim. Loose stones, missing stone dust, gaps and uneven surfaces have rendered the floor hazardous at best, and woe betide the bride in heels or young thespians in the throes of a Shakespearean soliloquy.

All Hallows Guild is addressing these areas - both because they require amendment and because the Amphitheater has our name on it. We built it and we must repair it. We expect to have the stone floor re-set in concrete to blend with the stonework in the Amphitheater steps, and are investigating measures such as porous paving for the eroded slope. Look at these “before” photographs of the damaged areas and keep watching for “after” pictures as we undertake the work.

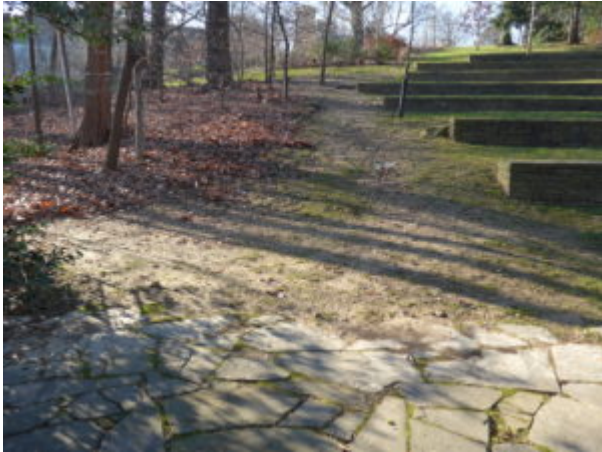
In addition, the steep hillside path descending into the Amphitheater at its southwest edge is a favorite shortcut from St. Albans across the Amphitheater to the other side of the Close. Like water, young feet seek the path of least resistance. No known ground cover can withstand the repeated trampling, with the result that the slope is either dry and caked dirt or rutted mud.
